March 4, 2021

Quincy Property, L.L.C.
900 NW Vesper Road
Blue Springs, MO 64015

RE: Structural Assessment of Building at 200 Maine Street, Quincy, IL

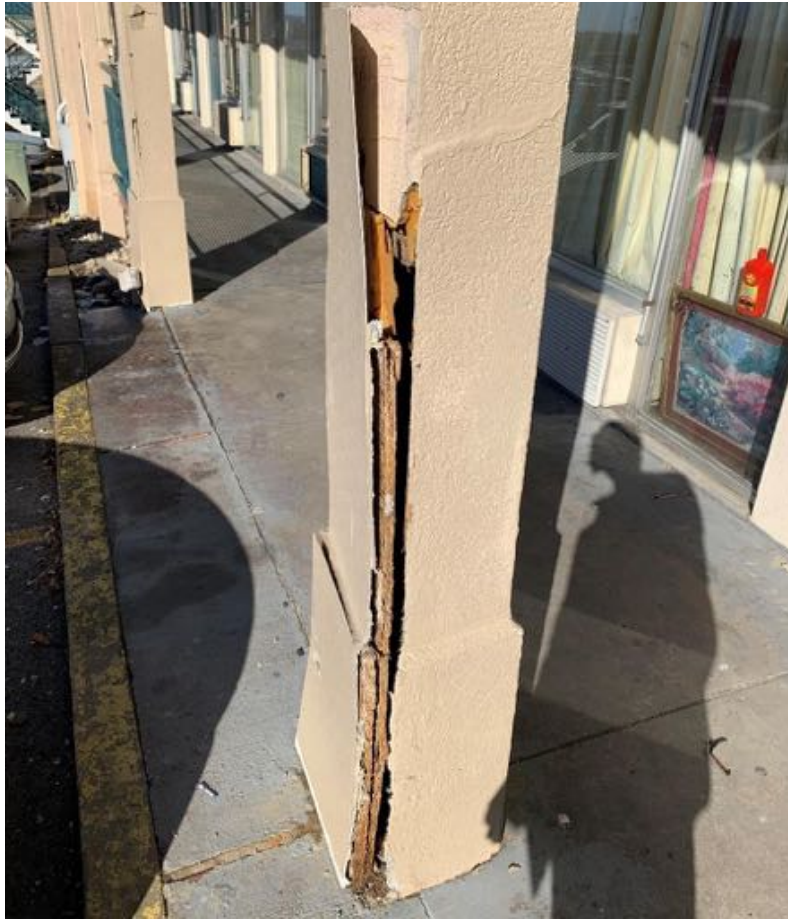
PHOTO 1

1. Broken or damaged column sheathing, exposing the columns to weather shown in PHOTO 1.
2. Paint delamination on the underside of exterior walkways and HSS beams shown in PHOTO 2 and PHOTO 3, respectively.

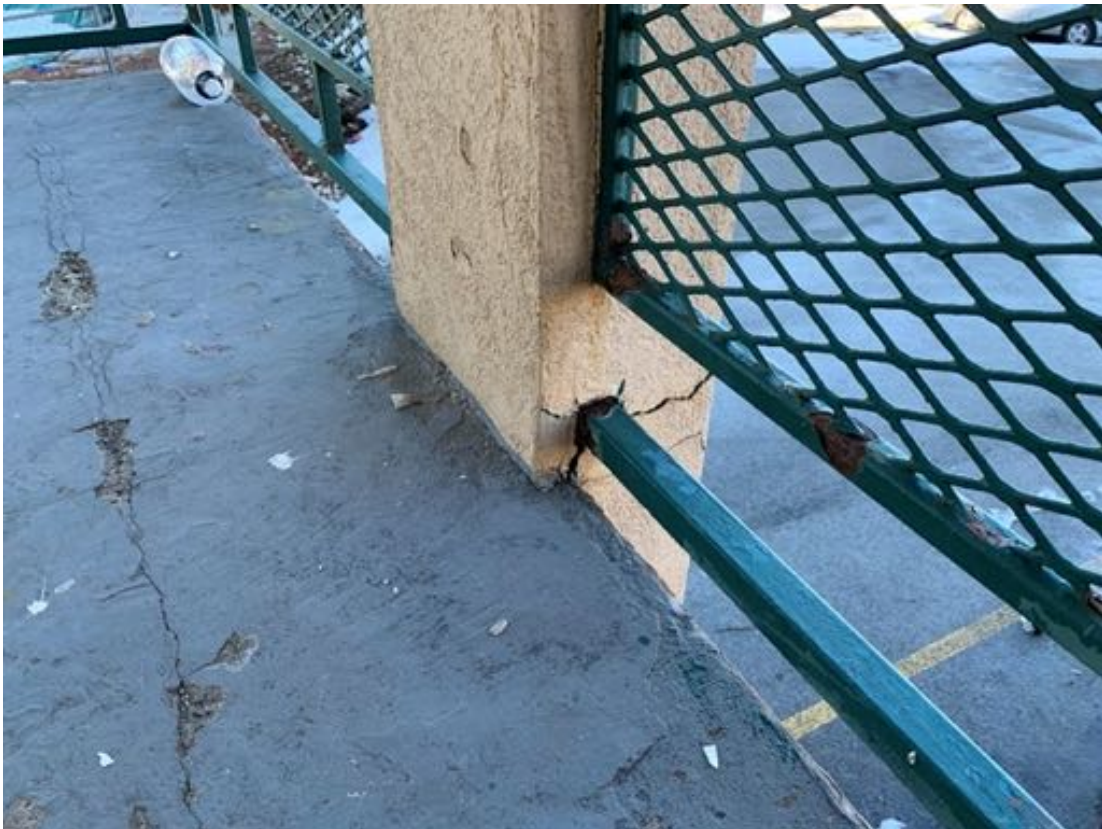
PHOTO 4

3. Corrosion of railings at support points shown in PHOTO 4.
4. Longitudinal cracking of exterior walkway hollow-core precast panels at construction joints (PHOTO 5) and adjacent to construction joints (PHOTO 6).

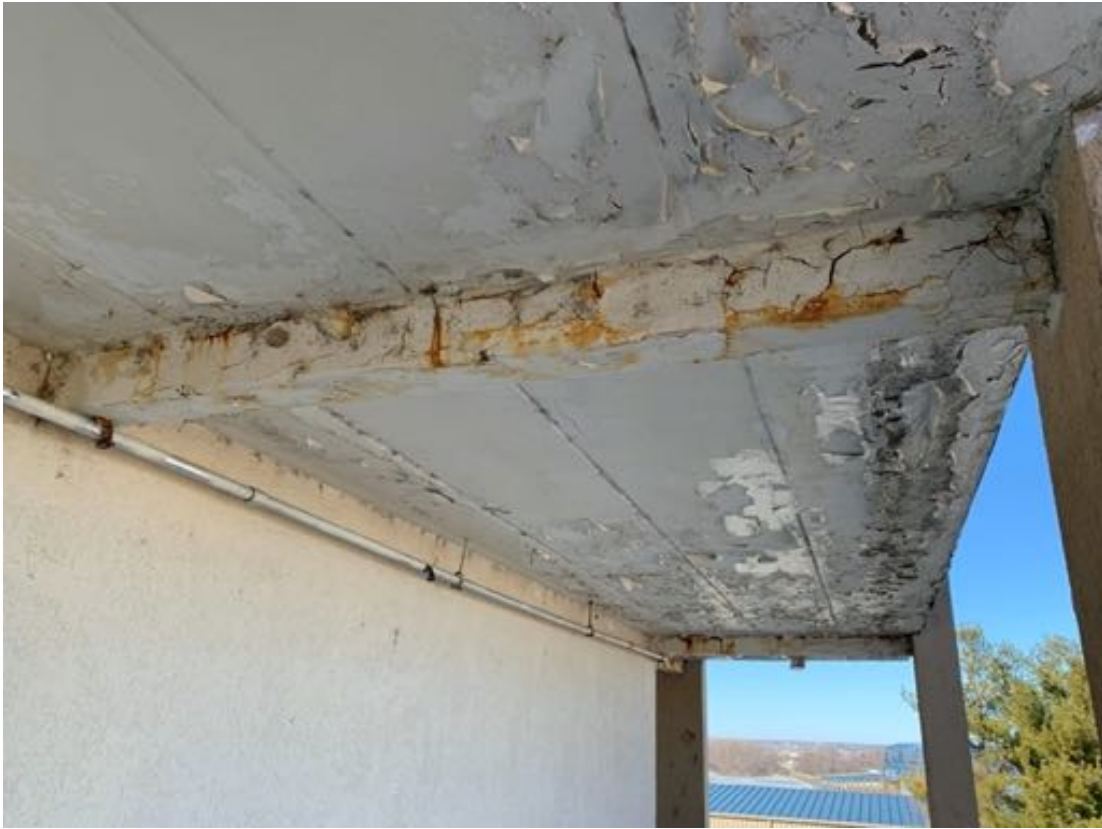
PHOTO 7

5. Moderate to severe corrosion of steel HSS beams. Moderate corrosion shown in PHOTO 7, severe corrosion shown in PHOTO 8.
6. Separation of steel HSS beams from supported concrete panels, shown in PHOTO 9.

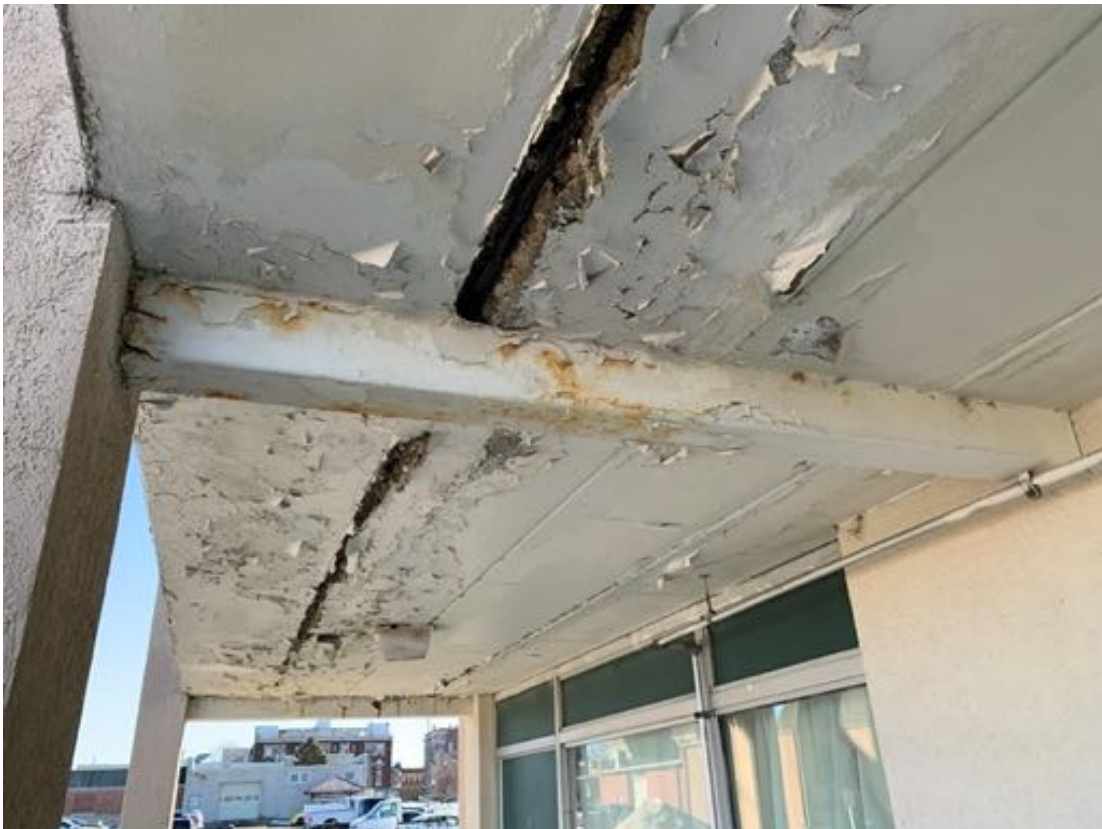
PHOTO 10

7. Spalling concrete on the underside of exterior walkway panels exposing reinforcing strands shown in PHOTO 10.
8. Topping material cracking at hollow-core construction joint locations shown in PHOTO 11.

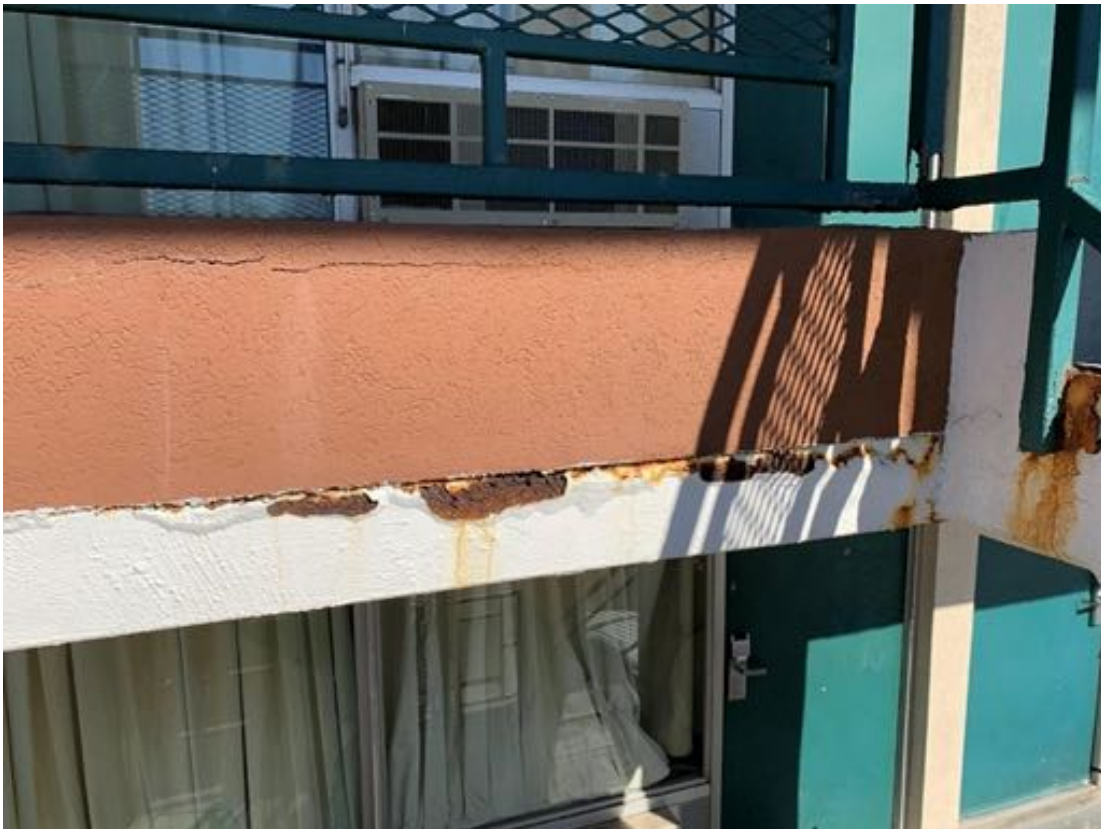
9. Moderate to severe corrosion of landing support beams in the exterior stairwells shown in PHOTO 12 and PHOTO 13, respectively.
10. Cracking of central support column in exterior stairwells shown in PHOTO 14.

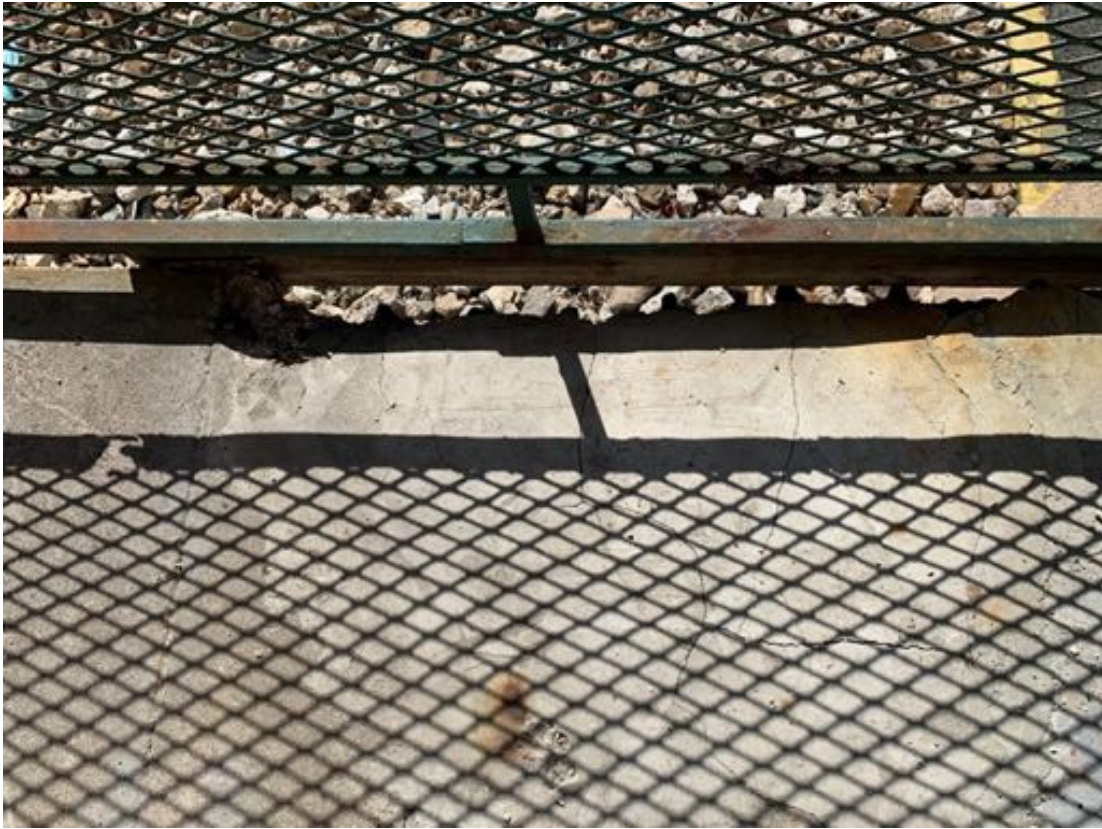
PHOTO 15

11. Extensive concrete spalling of exterior stairwell intermediate landings, exposing reinforcing steel shown in PHOTO 15.
12. Severe corrosion at handrail support locations shown in PHOTO 16.

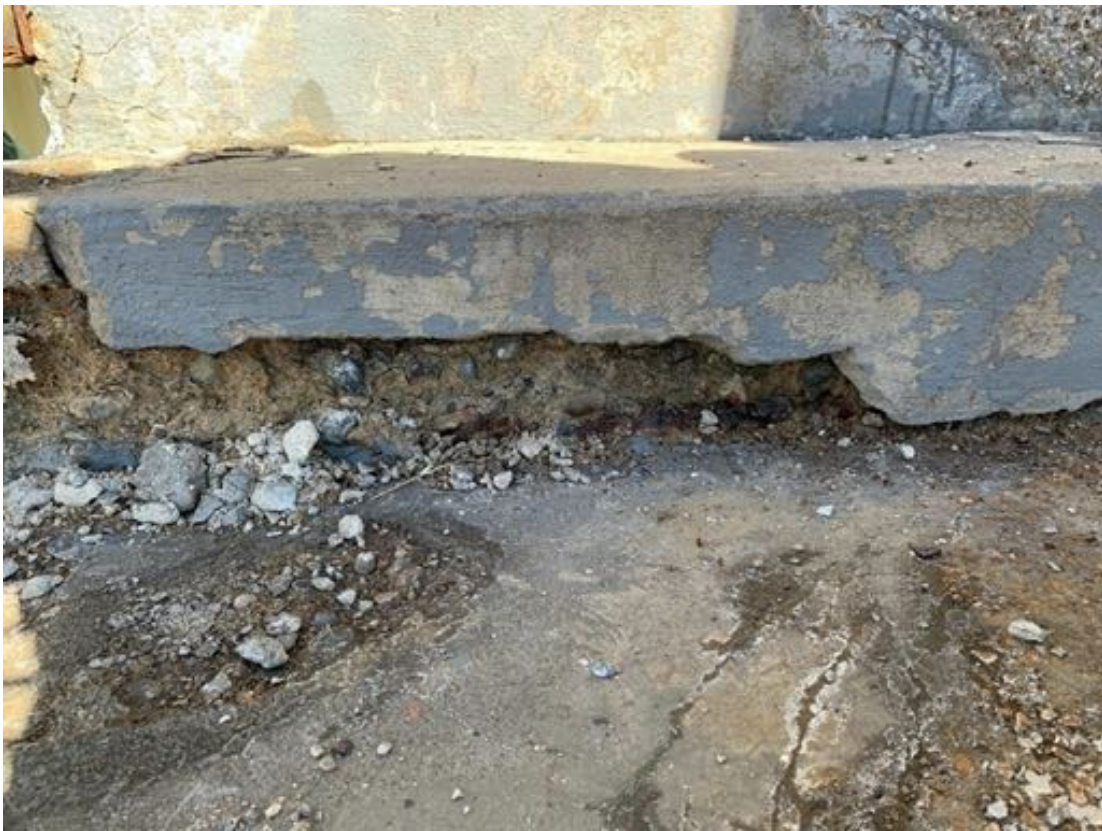
PHOTO 18

13. Longitudinal cracking parallel to panel joints on the underside of the exterior walkway exposing reinforcing strands shown in PHOTO 17.
14. Spalling of steps in exterior stairwells shown in PHOTO 18.
15. Longitudinal cracking on the underside of stairway flights in exterior walkways shown in PHOTO 19.

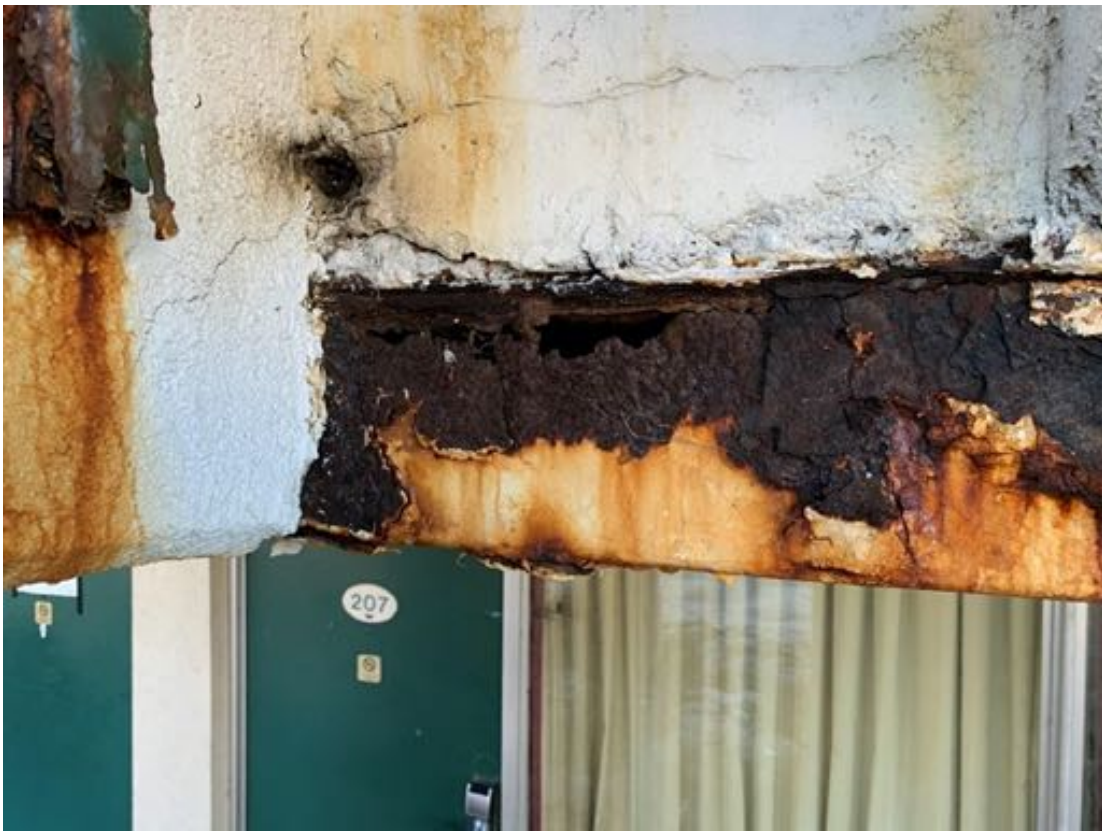
PHOTO 20

Structural components classified as being in Tier 1 require immediate action to prevent damage to property or injury to persons, a general example of Tier 1 structural distress can be seen in PHOTO 20. Structural components identified as being in Tier 1 would include any reinforced concrete member with exposed steel reinforcing bars or strands, any steel HSS (Hollow Structural Section) exhibiting severe corrosion, and any hand railing that has broken loose of one or more of its anchor points or corroded to the extent of being unsafe. Photos of each specific area are identified in the "Structural Components Classified as Tier 1" section and attached later in this report.

To resolve the Tier 1 structural issues, these components must be replaced or repaired in such a way as to correct the underlying issue. Repairing many of these structural sections could be costly in terms of time and money and therefore may be more economical to replace these components instead of repairing them. For example, all corroded reinforcing steel must be removed from the concrete and replaced with new reinforcing steel. This is impractical to do with the hollow-core slabs due to the nature of their design and construction. For cast-in-place reinforced concrete with corroded or exposed reinforcing steel, it may be possible to remove and replace the necessary steel without replacing the entire structural section if there is not extensive damage.

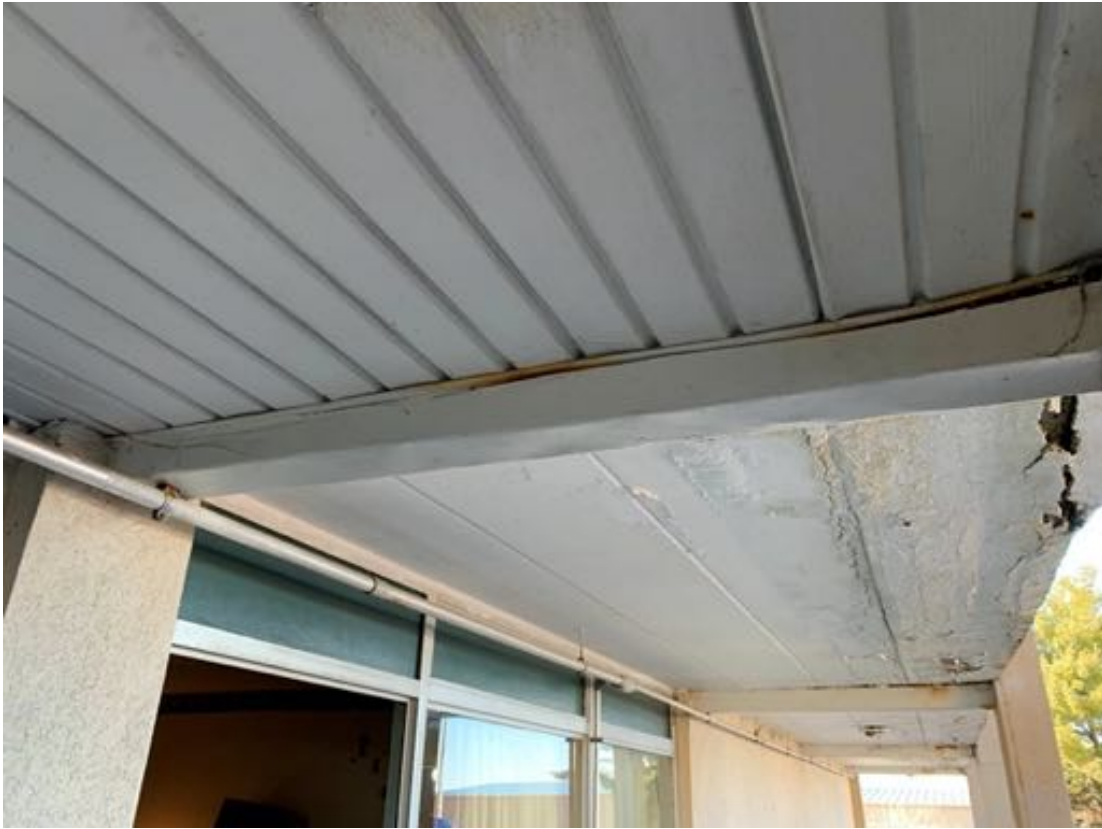
PHOTO 21

Structural components identified as being in Tier 2 require further investigation to determine the extent of damage/degradation, an general example of Tier 2 structural distress can be seen in PHOTO 21. Structural components identified as being in Tier 2 would include any hollow-core slab (elevated exterior walkways) showing transverse cracking at midspan, any hollow-core slab exhibiting longitudinal cracking adjacent to a panel joint, any hollow-core slab that was covered with sheathing preventing visual inspection, any steel HSS beam covered with sheathing preventing visual inspection, any steel HSS beam adjacent to a hollow-core slab covered with sheathing preventing visual inspection of said steel HSS beam, any reinforced concrete column exhibiting moderate cracking, or any reinforced concrete stairway flight section exhibiting longitudinal or other moderate cracking.

Due to the nature of Tier 2, these components may fall in either Tier 1 or Tier 3, but were unable to be classified during the site visit due to various reasons such as being obscured by temporary sheathing, requiring partial demolition, time constraints, etc. Consequently, more extensive investigation is necessary to properly ascertain the extent of damage and to determine whether replacement or repairs are necessary.

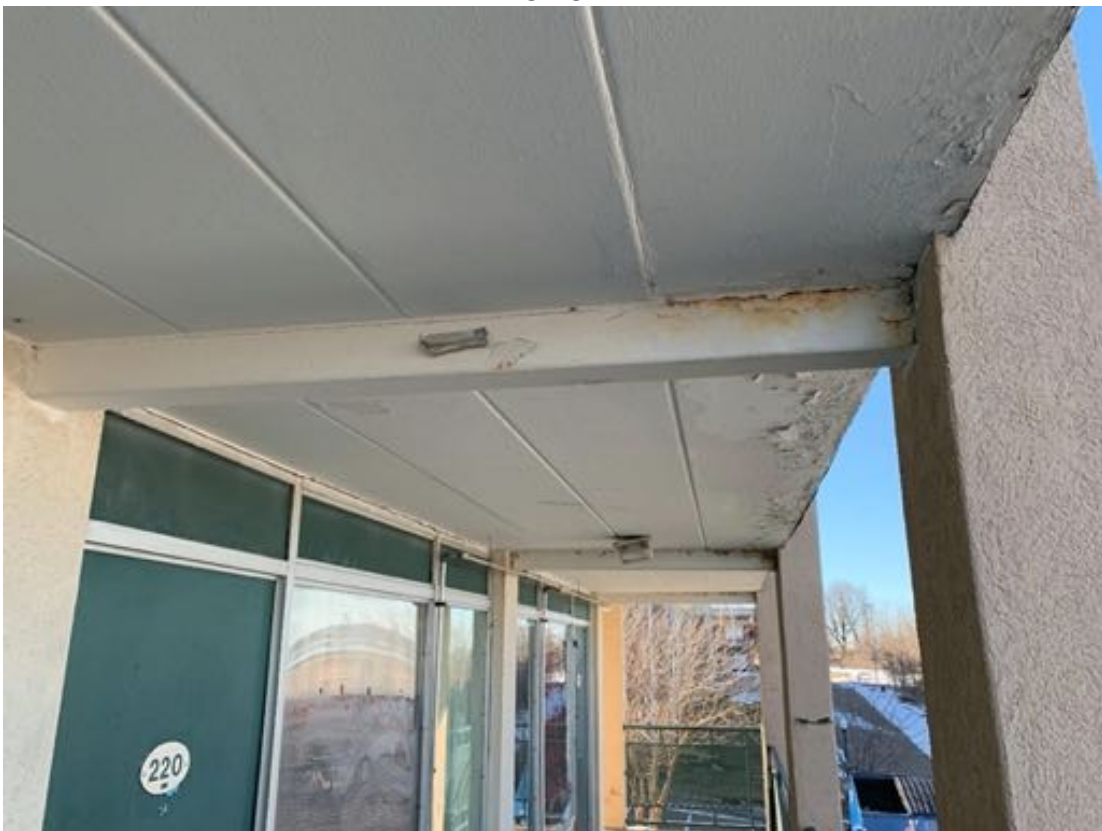
PHOTO 22

Structural components identified as being in Tier 3 will require preventative maintenance in the future to prevent significant degradation, an general example of example of Tier 3 structural distress can be seen in PHOTO 22. Structural components identified as being in Tier 3 would include any hollow-core slab exhibiting peeling or flaking paint, any steel HSS beam exhibiting peeling or flaking paint, any hand railing exhibiting peeling or flaking paint, any column wrap that is damaged in such a way as to allow water intrusion, and any other wrap that is damaged in such a way as to allow water intrusion.

As for the structural components in Tier 3, their condition does not appear to pose an immediate threat to persons or property. However, if these components are left in their current conditions, they may become a risk to persons and property in the future. To prevent these components from degrading over time, it would be best to remove rust from steel members via sand blasting or other appropriate methods, stop water intrusion by waterproofing, regrouting or fixing column enclosures, and painting to protect from weather. For the hollow-core slabs that fall into this category, it is recommended to remove and replace the layer of concrete topping on the affected slabs as well re-painting the bottom side. For the steel members in this category, it is recommended to remove rust before applying paint.

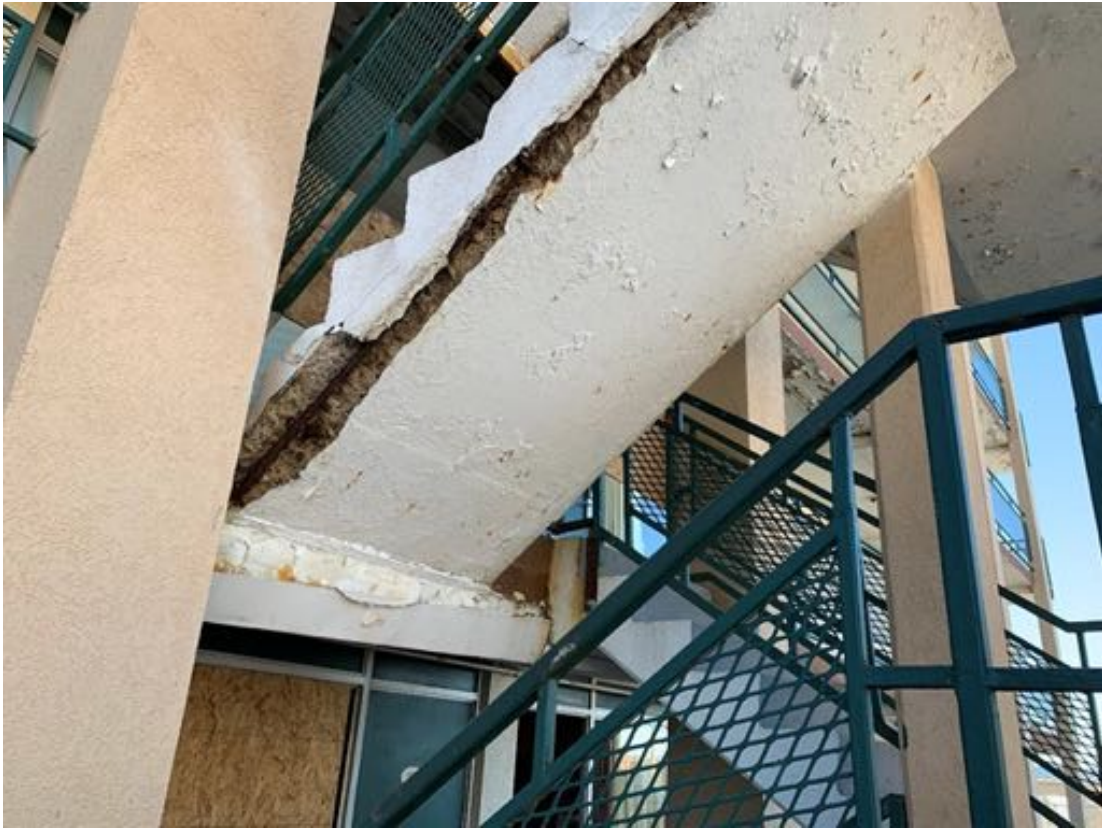
1. Stairway flight from 2nd level landing to intermediate landing between levels 2 and 3 in the northwest stairwell. PHOTO 23
2. Steel HSS beam supporting 3rd level landing in northwest stairwell. PHOTO 24
3. Intermediate landing between 2nd and 3rd level in the northwest stairwell. PHOTO 25
4. Hand railing in the northwest stairwell. PHOTO 26
5. Intermediate landing between ground level and 2nd floor in the northwest stairwell. PHOTO 27

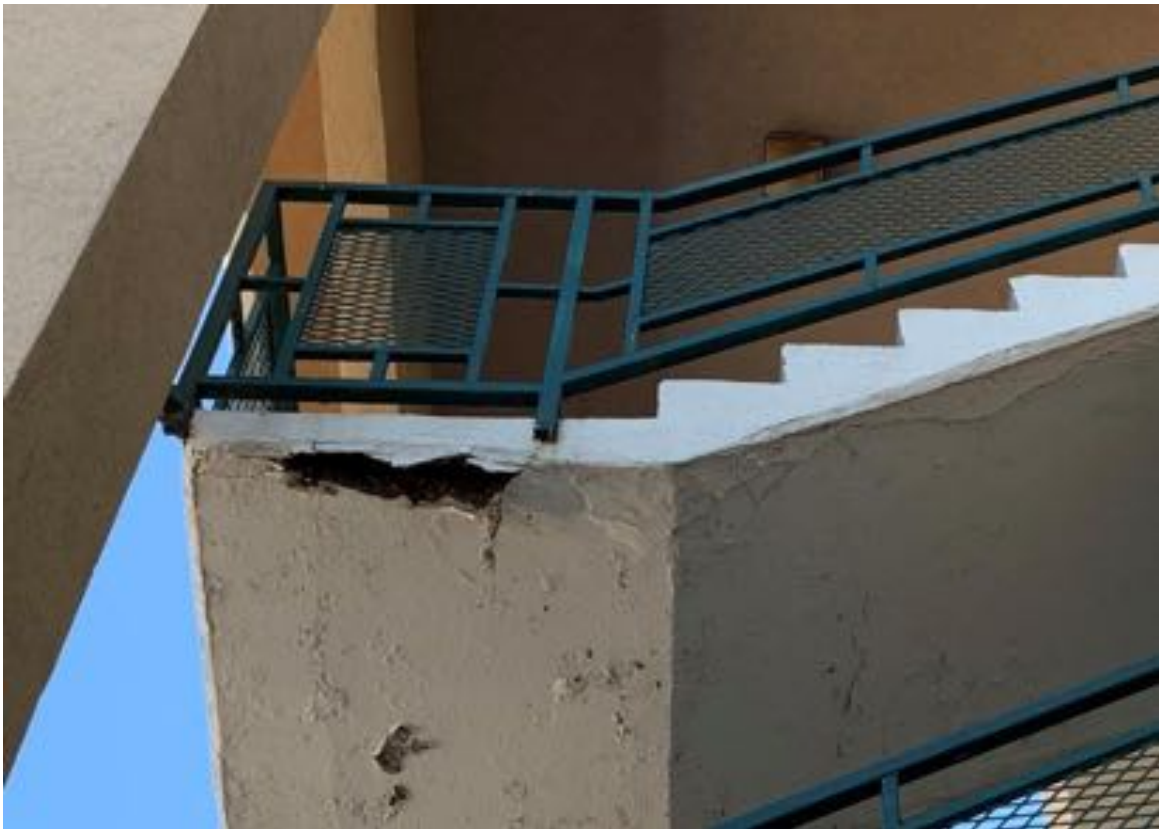
PHOTO 28

6. Intermediate landing between the 3rd and 4th level in the northwest stairwell. PHOTO28
7. Hand railing between the 2nd and 3rd level in the southwest stairwell. PHOTO 29

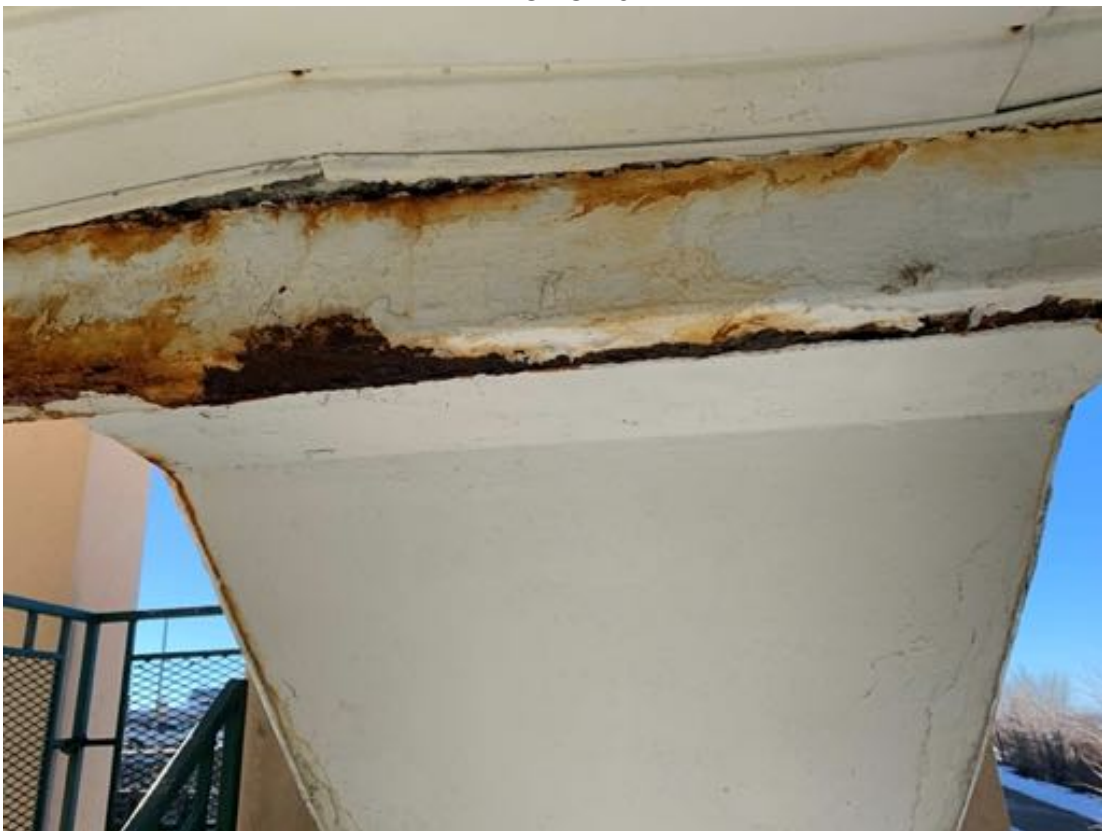
8. Steel HSS beam supporting the 3rd level landing in southwest stairwell. PHOTO 30
9. Intermediate landing between the ground level and 2nd floor in the northeast stairwell. PHOTO 31

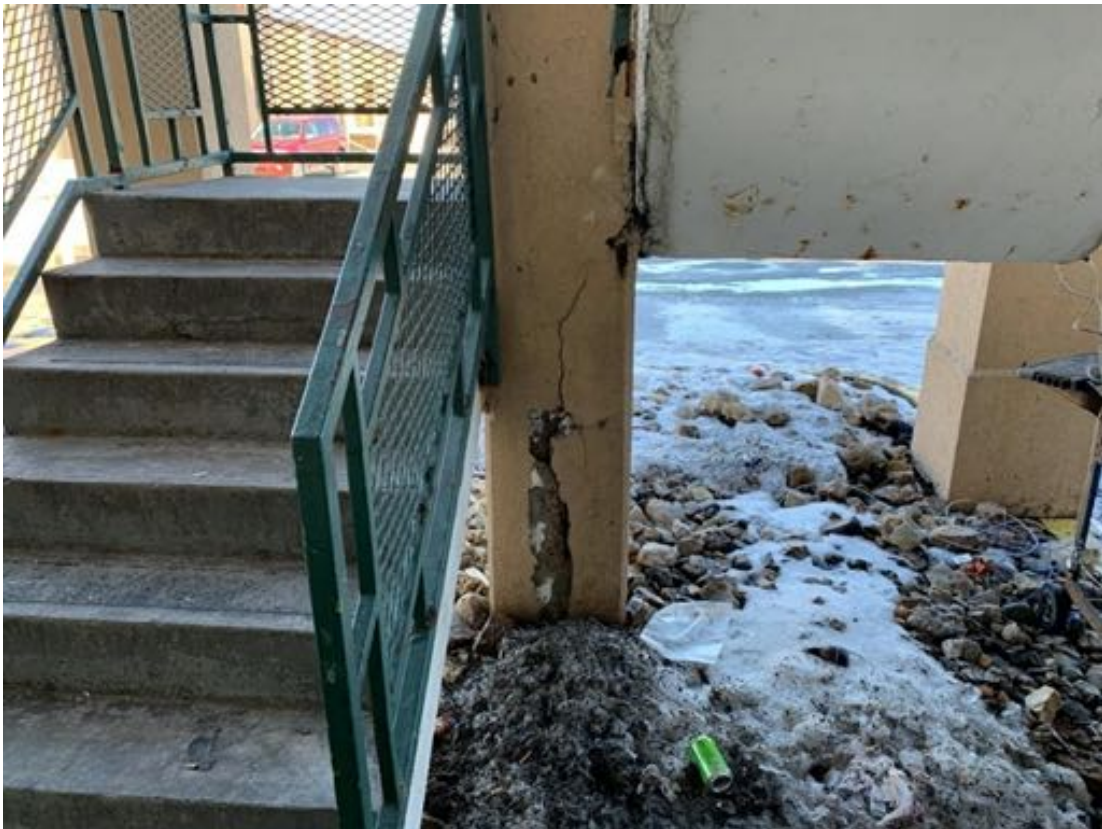
10. Center column in the northeast stairwell. PHOTO 32
11. Stairway flight between 2nd level and intermediate landing in the northeast stairwell. PHOTO 33

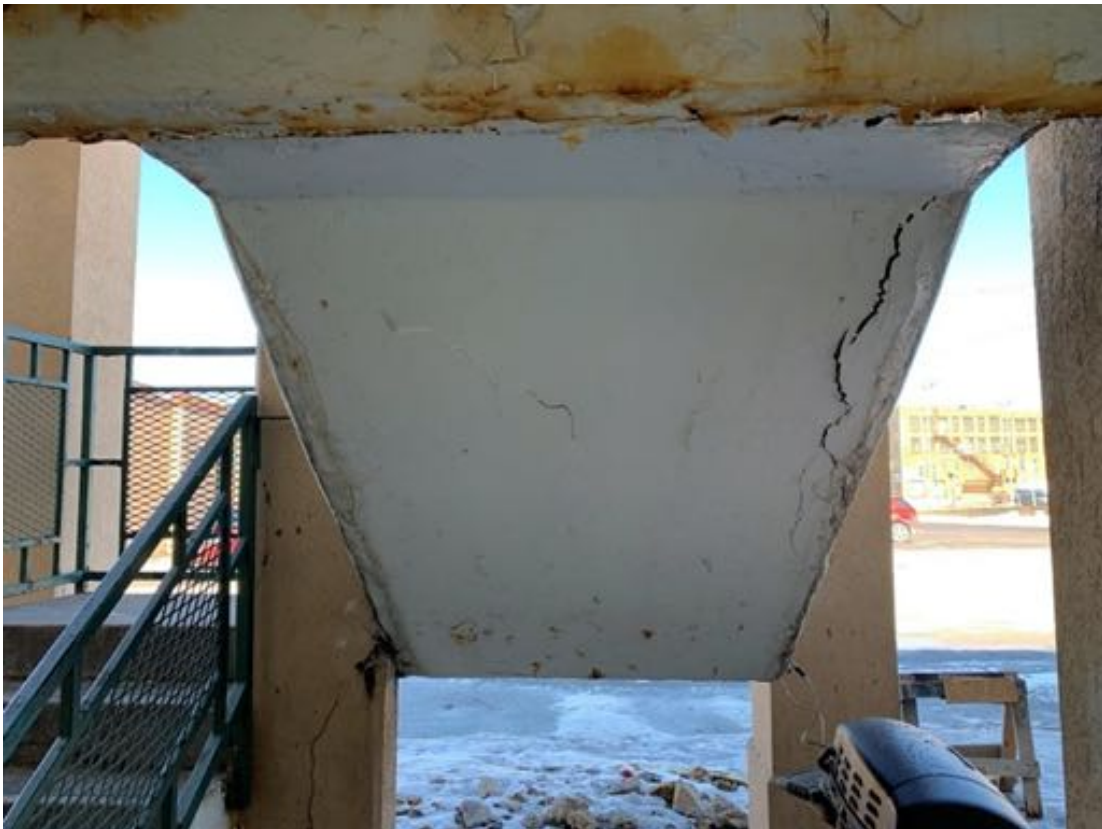
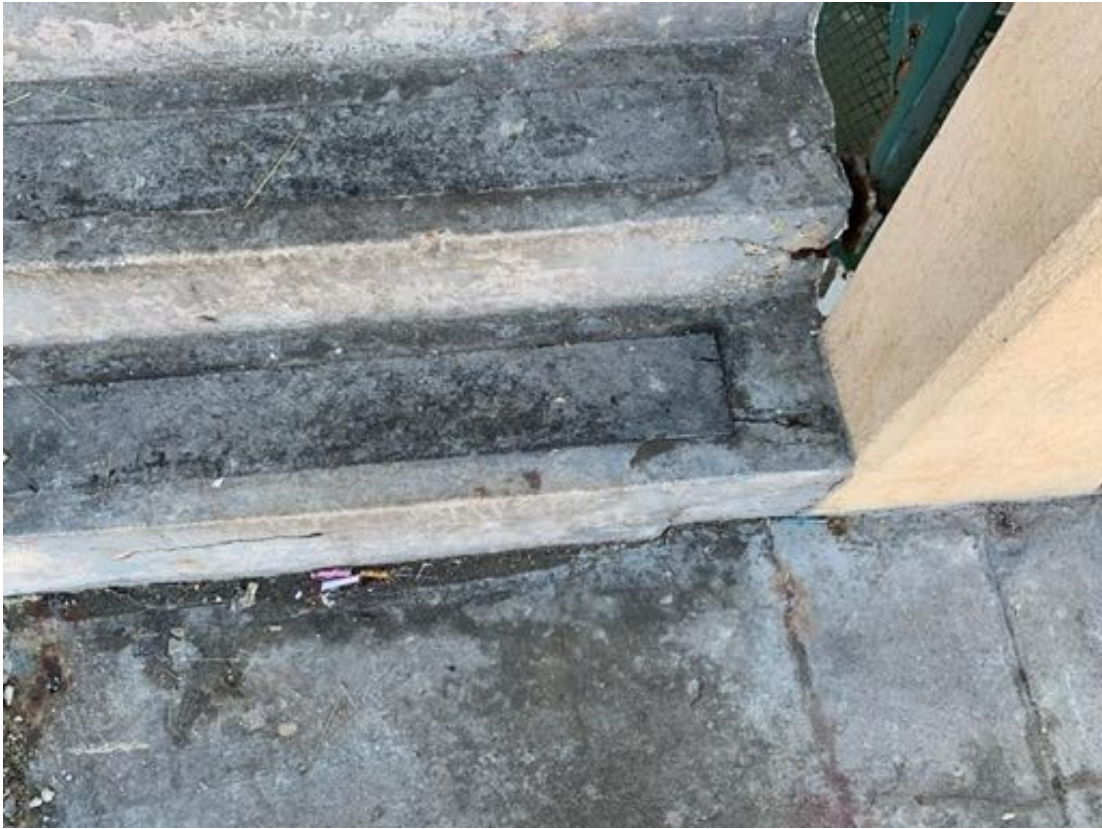
PHOTO 34 (Bottom)

12. Stairway flight between the intermediate landing and the 3rd floor in the northeast stairwell. PHOTO 34
13. Steel HSS beam under the 3rd level landing in the northeast stairwell. PHOTO 35

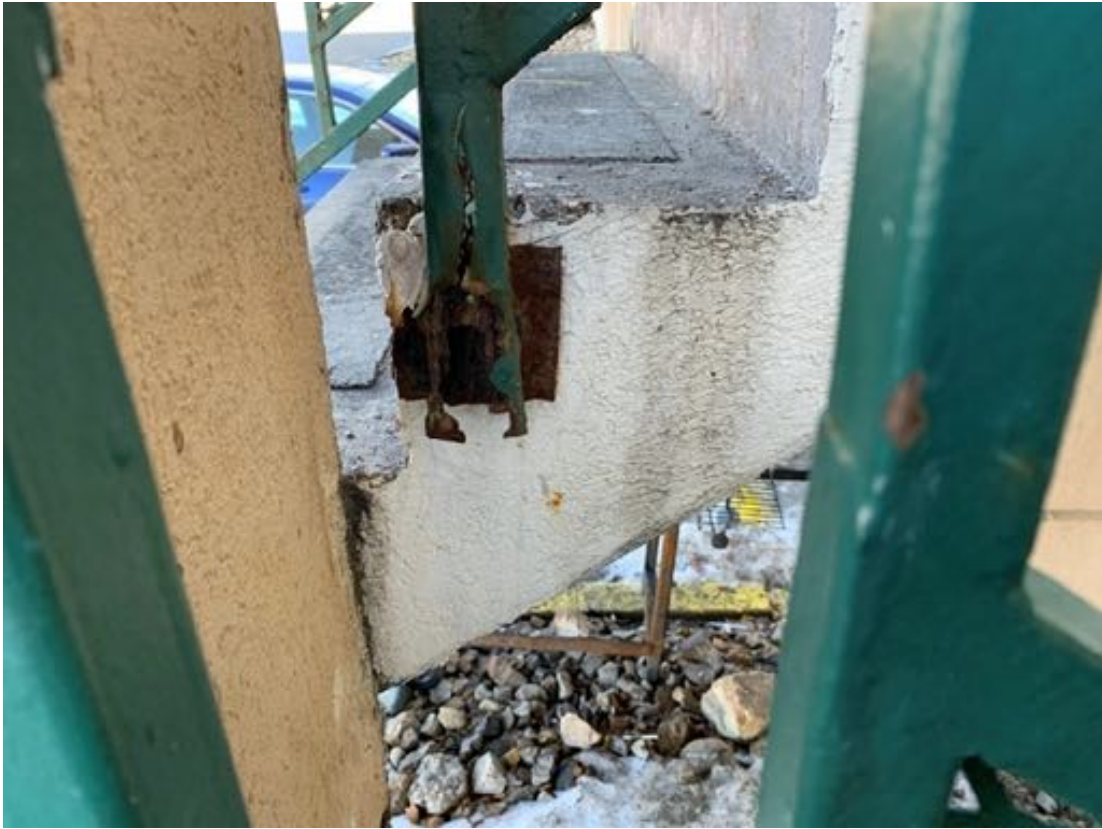
14. Hand railing from the 2nd level to the 3rd level in the northeast stairwell. PHOTO 36
15. Stairway flight between the 4th level and the intermediate landing in the southwest stairwell. PHOTO 37

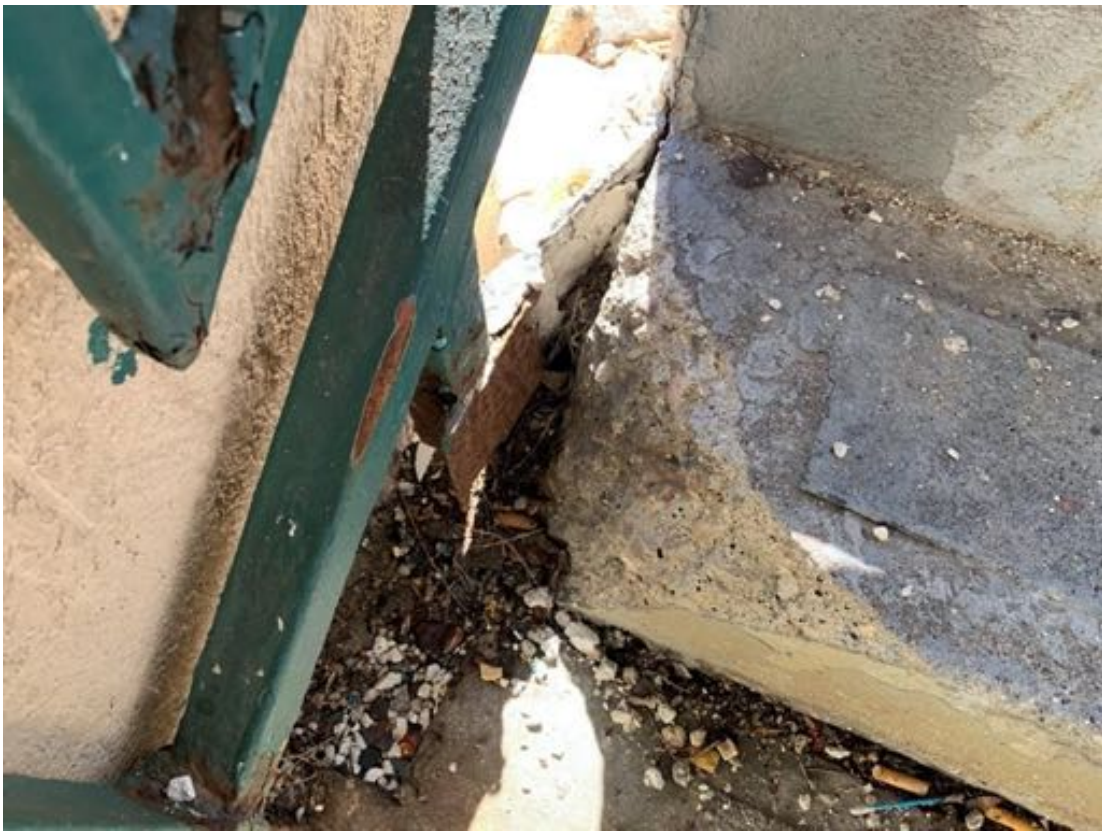
16. Steel HSS beam supporting the 2nd floor landing in the southwest stairwell. PHOTO38
17. Hand railing between the 1st level and the 2nd level in the southwest stairwell. PHOTO 39

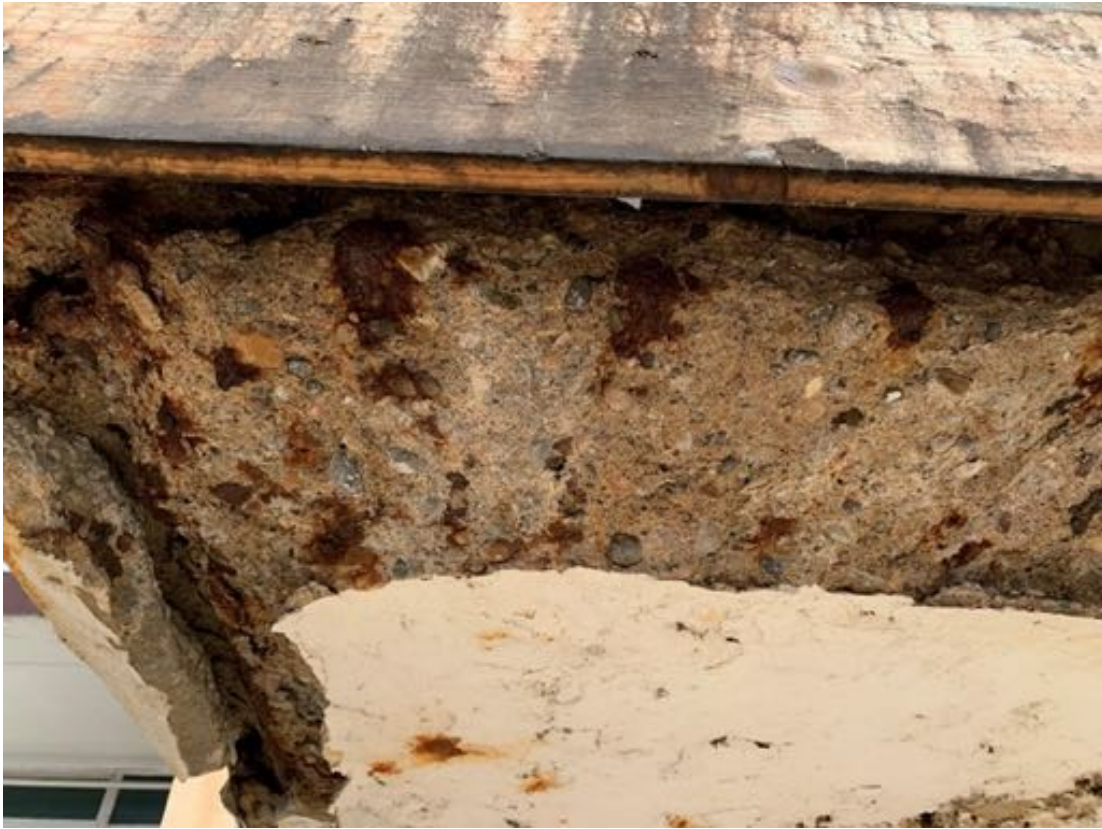
18. Intermediate landing between the 1st and 2nd level in the southwest stairwell. PHOTO 40
19. Hand railing from the 3rd level to the 4th level in the southeast stairwell. PHOTO 41

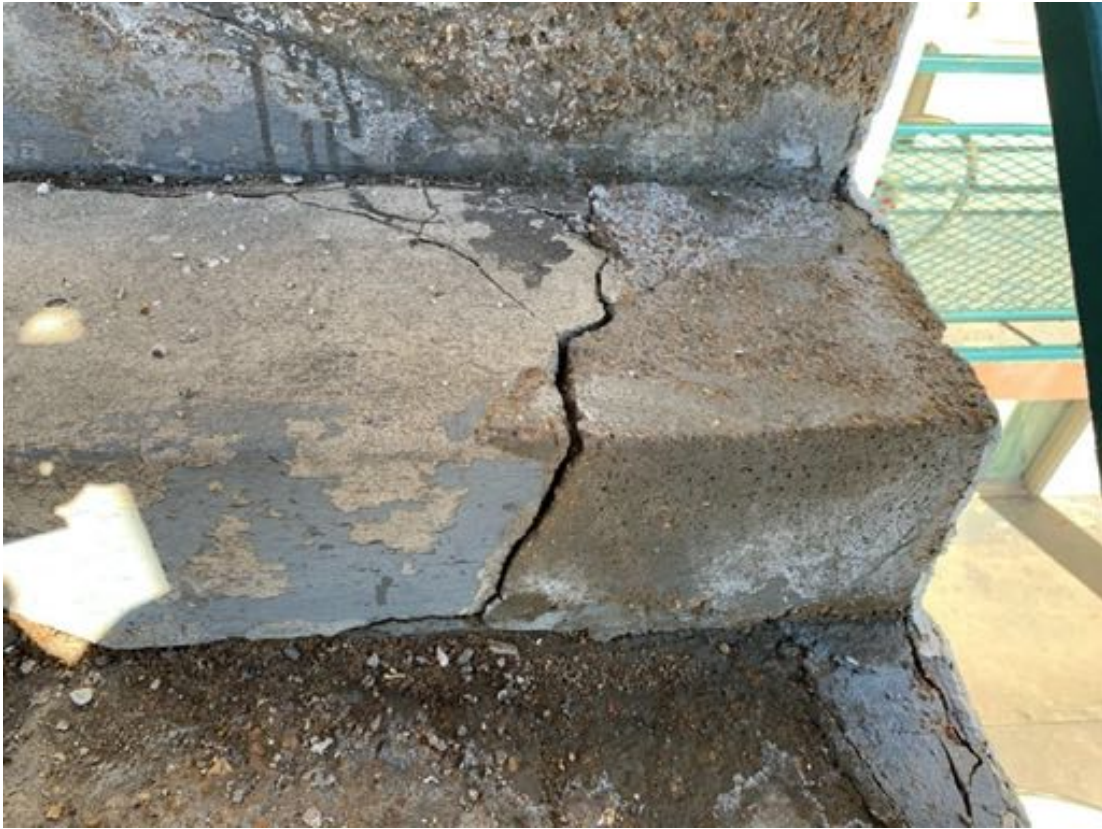
20. Stairway flight between the intermediate landing and 4th level in the southeast stairwell. PHOTO 42
21. Intermediate landing between the 3rd and 4th level in the southeast stairwell. PHOTO43

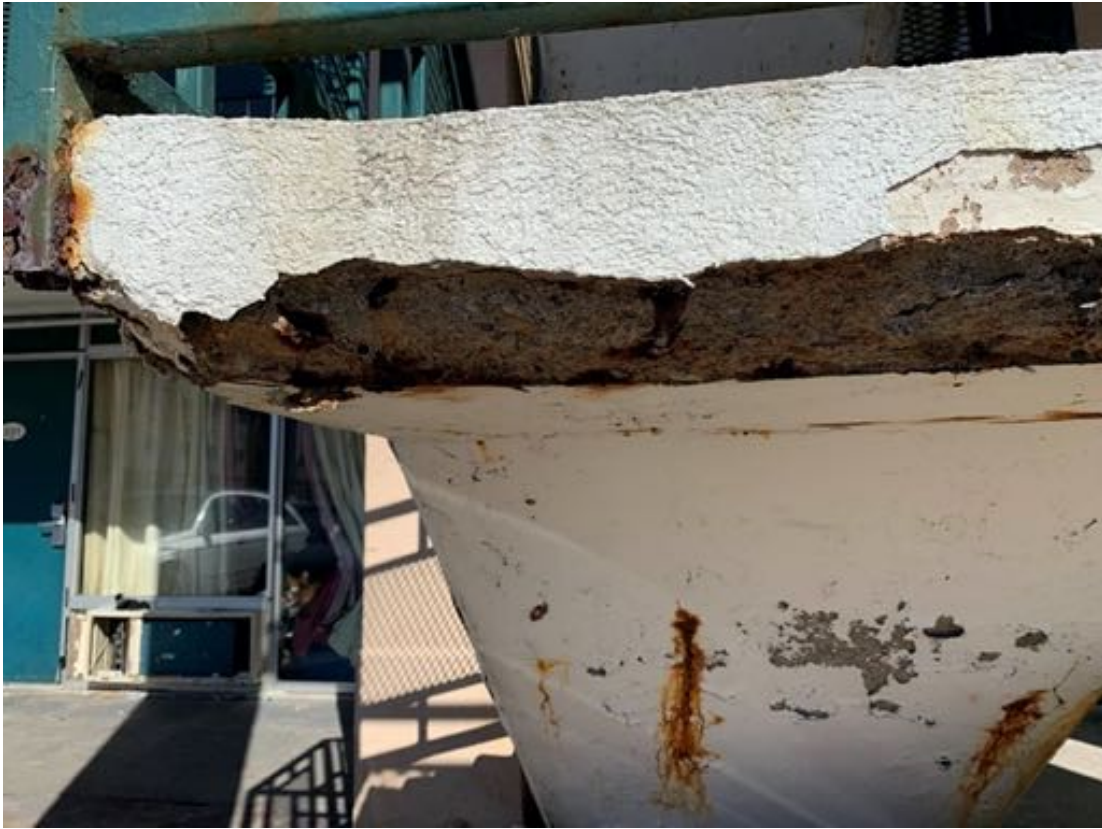
22. Intermediate landing between the 2nd and 3rd level in the southeast stairwell. PHOTO 44
23. Hand railing between the 2nd and 3rd level in the southeast stairwell. PHOTO 45

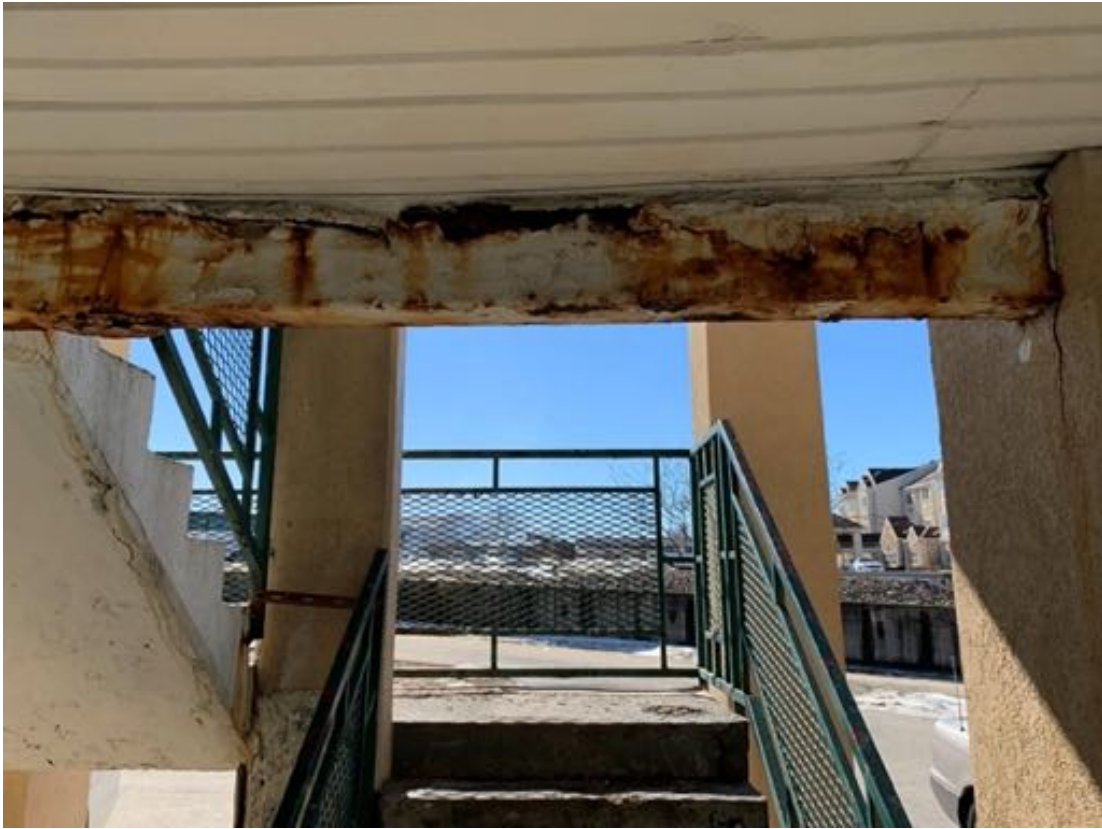
PHOTO 46

24. Steel HSS beam supporting the 3rd level landing in the southeast stairwell. PHOTO46
25. Hollow-core panel in front of room 117 between 1st and 2nd level. PHOTO 47
