March 4, 2021

Quincy Property, L.L.C.
900 NW Vesper Road
Blue Springs, MO 64015

RE: Structural Assessment of Building at 200 Maine Street, Quincy, IL

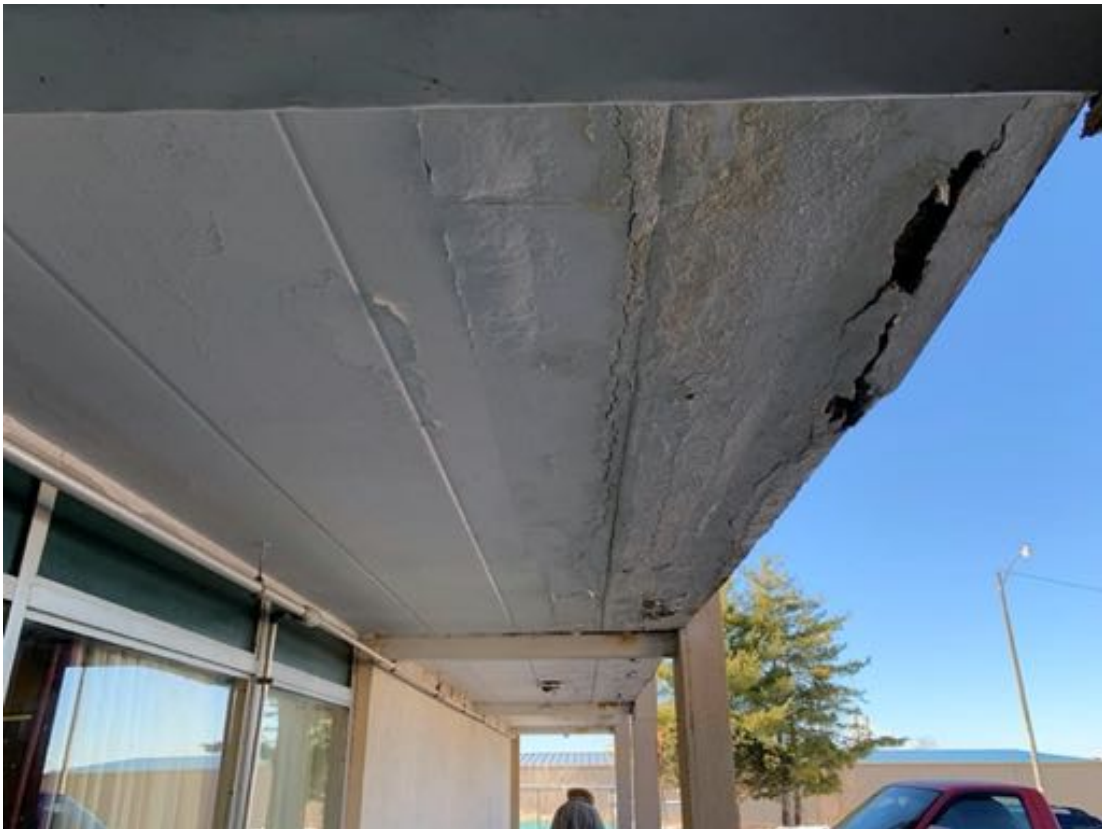
24. Steel HSS beam supporting the 3rd level landing in the southeast stairwell. PHOTO46
25. Hollow-core panel in front of room 117 between 1st and 2nd level. PHOTO 47

To resolve the Tier 1 structural issues, these components must be replaced or repaired in such a way as to correct the underlying issue. Repairing many of these structural sections could be costly in terms of time and money and therefore may be more economical to replace these components instead of repairing them. For example, all corroded reinforcing steel must be removed from the concrete and replaced with new reinforcing steel. This is impractical to do with the hollow-core slabs due to the nature of their design and construction. For cast-in-place reinforced concrete with corroded or exposed reinforcing steel, it may be possible to remove and replace the necessary steel without replacing the entire structural section if there is not extensive damage.

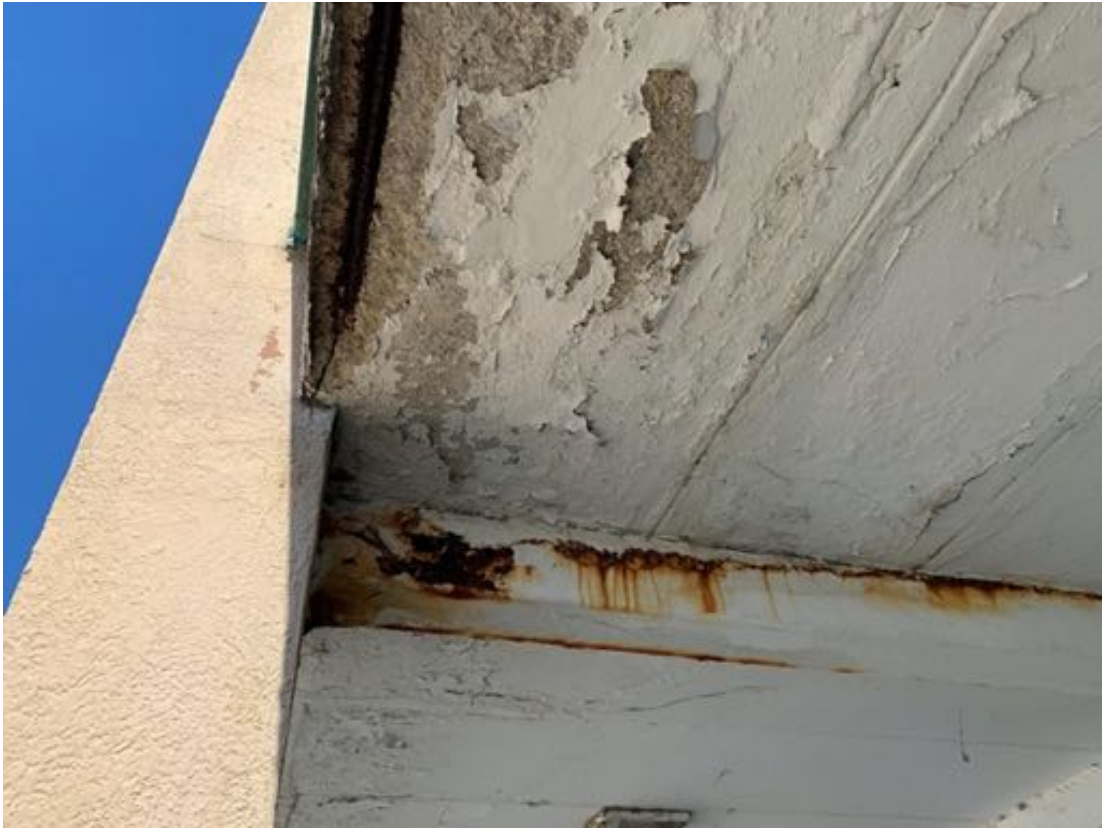
26. Hollow-core slab in front of room 118. PHOTO 48
27. Hollow-core slab in southwest corner of building between the 1st and 2nd levels. PHOTO 49
28. Hollow-core slab in front of room 122. PHOTO 50

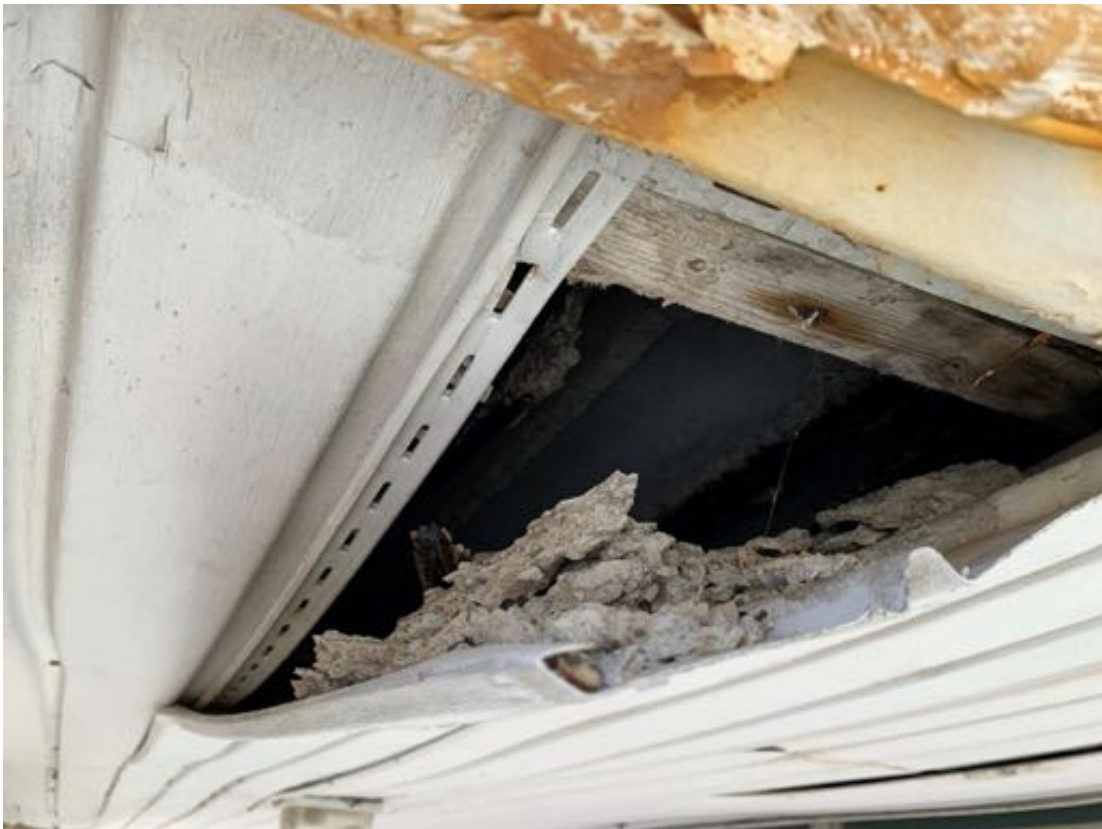
29. Hollow-core slab in front of room 123 (2nd floor landing of southwest stairwell). PHOTO 51
30. Hollow-core slab in front of room 124. PHOTO 52
31. Hollow-core slab between 1st and 2nd level on the south side of the western interior stairwell. PHOTO 53

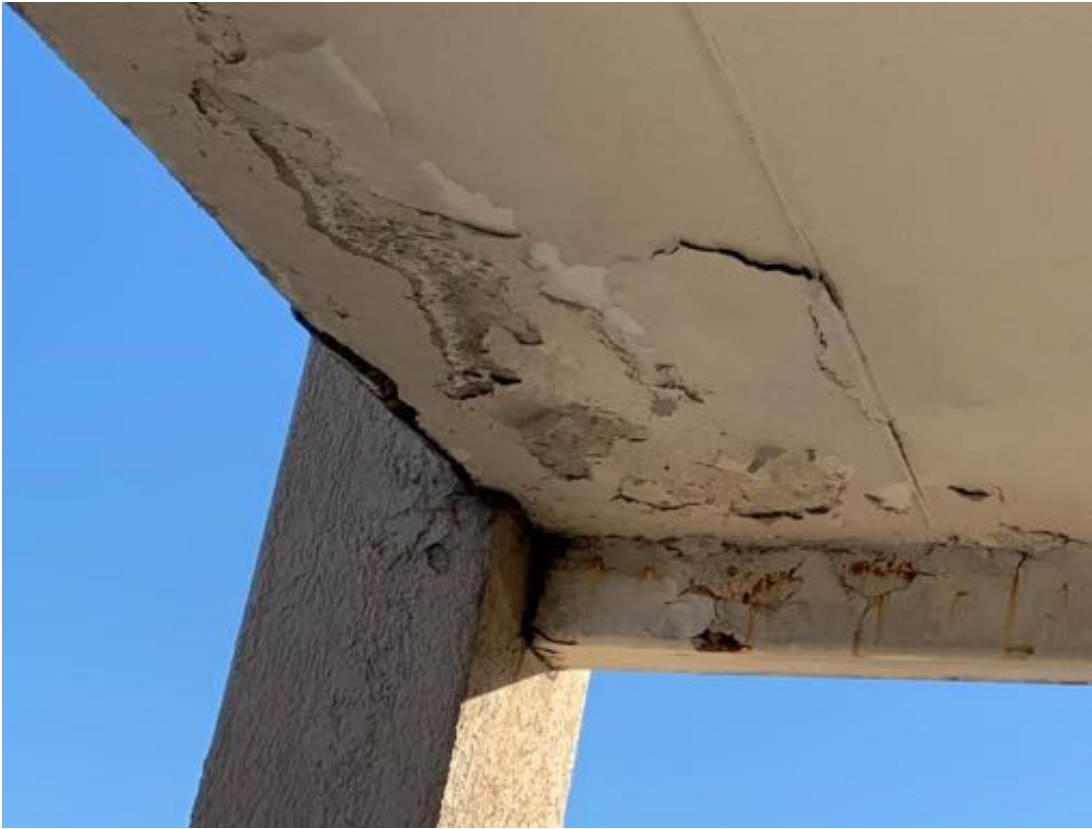
32. Hollow-core slab in front of room 201 between 2nd and 3rd levels. PHOTO 54
33. Hollow-core slab in front of room 203 between 2nd and 3rd levels. PHOTO 55

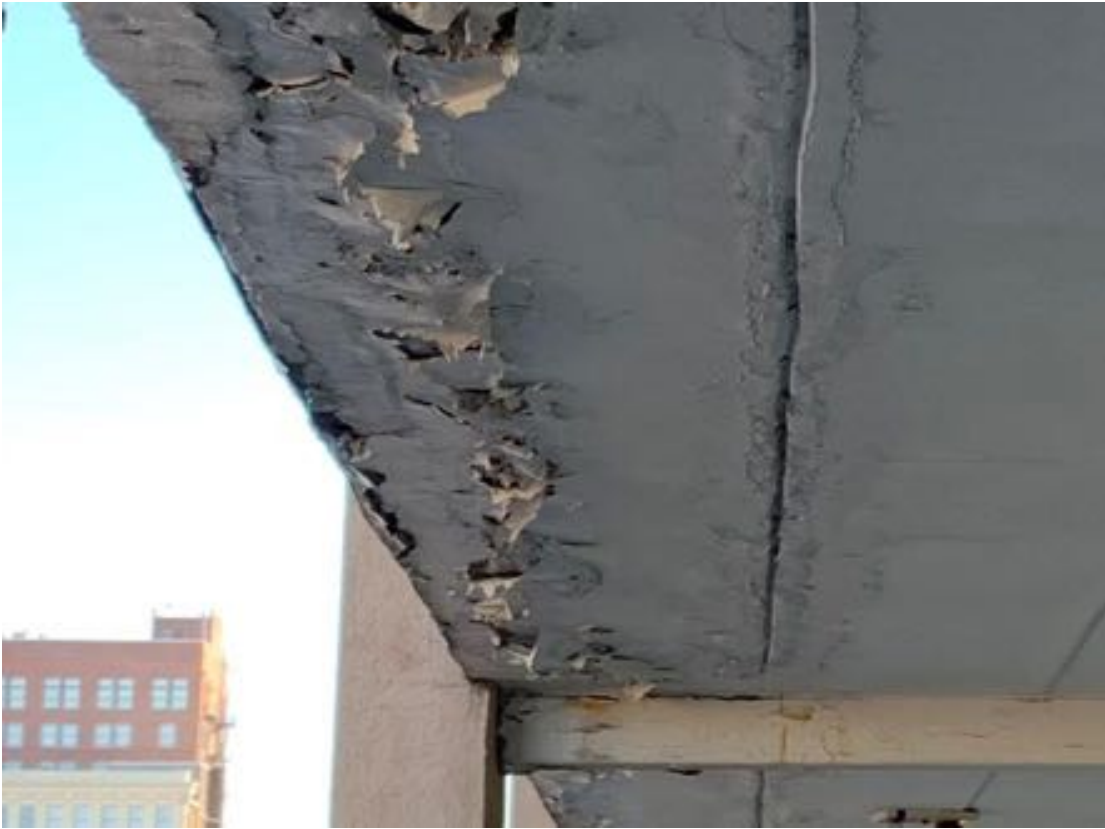
34. Hollow-core slab in front of room 204 between 2nd and 3rd levels. PHOTO 56
35. Hollow-core slab in front of room 208 between 2nd and 3rd levels. PHOTO 57

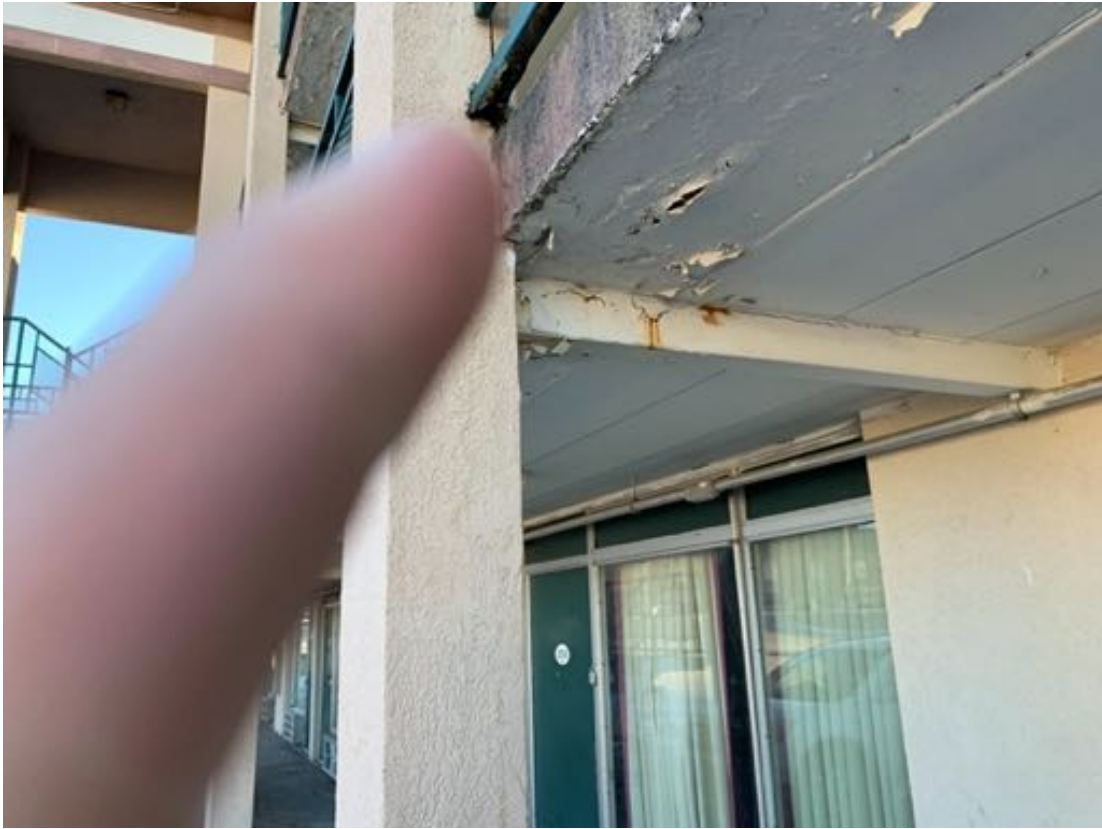
36. Hand railing in front of room 310. PHOTO 58
37. Hollow-core slab north of the western interior stairwell between 2nd and 3rd level. PHOTO 59

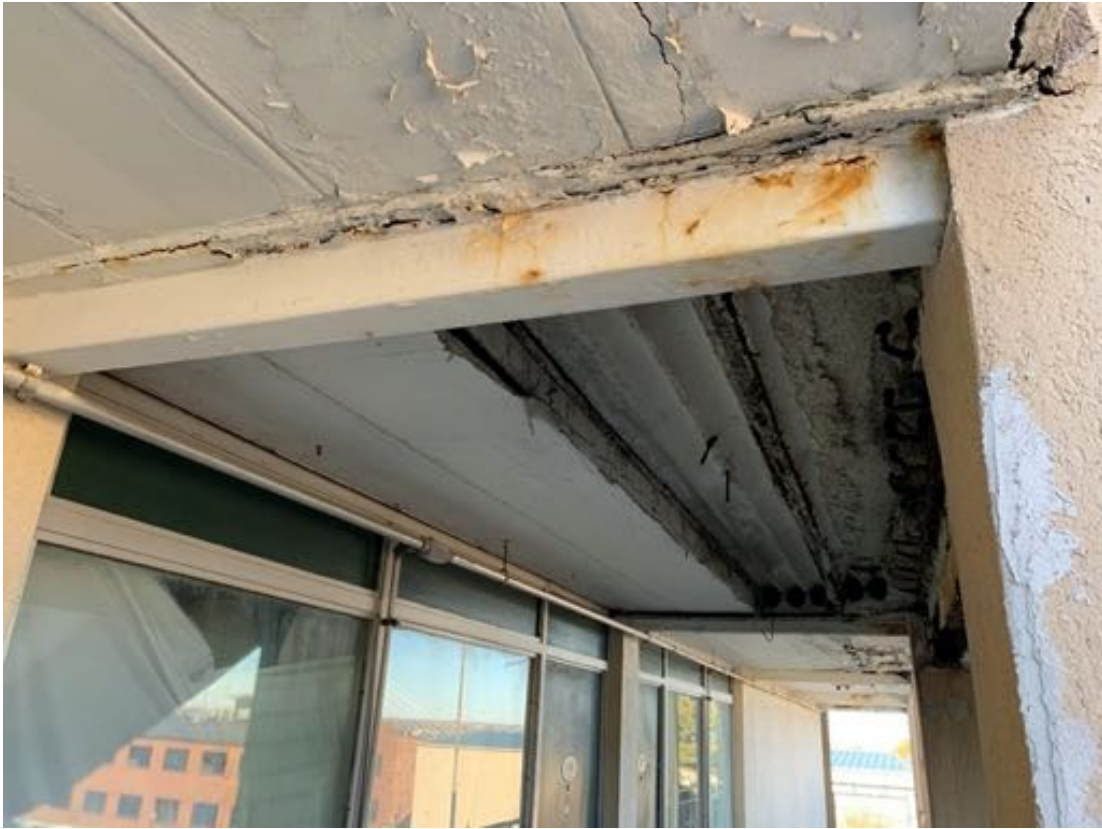
38. Hollow-core slab in front of room 216 between 2nd and 3rd level. PHOTO 60
39. Hollow-core slab in front of room 217 between 2nd and 3rd level. PHOTO 61

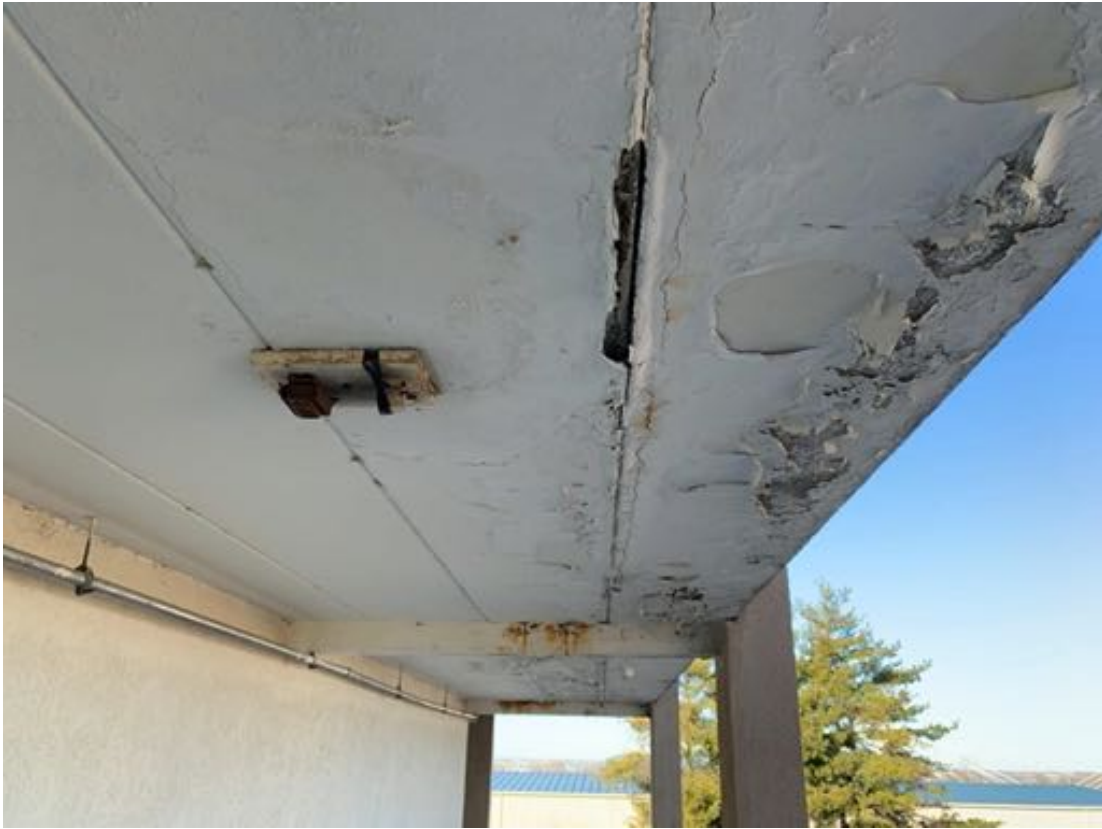
40. Hollow-core slab west of room 217 (second full length slab from west end of building) between 2nd and 3rd level. PHOTO 62
41. Hollow-core slab west of room 217 (last full-length slab from west end of building) between 2nd and 3rd level. PHOTO 63

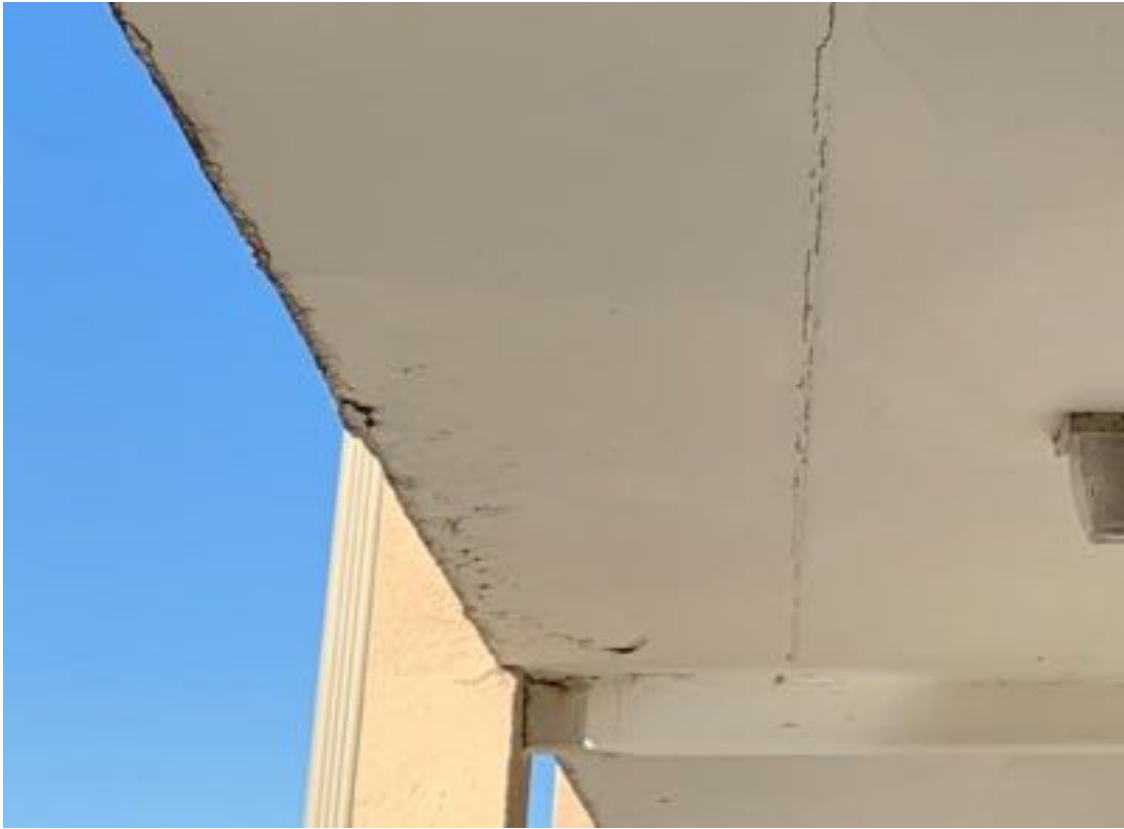
42. Hollow-core slab west of room 222 (second to last full-length slab from west end of building) between 2nd and 3rd level. PHOTO 64
43. Hollow-core slab in front of room 222 between 2nd and 3rd level. PHOTO 65

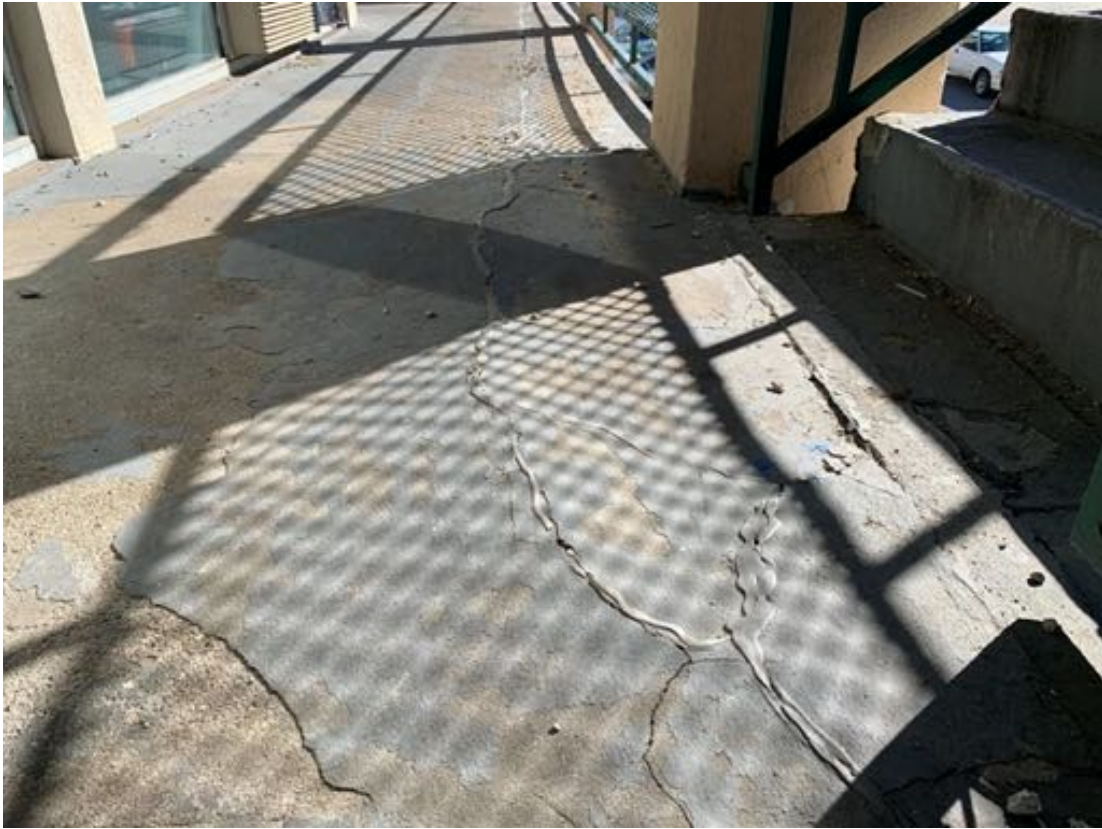
44. Hollow-core slab in front of room 223 between 2nd and 3rd level. PHOTO 66
45. Hollow-core slab in front of room 224 between 2nd and 3rd level. PHOTO 67

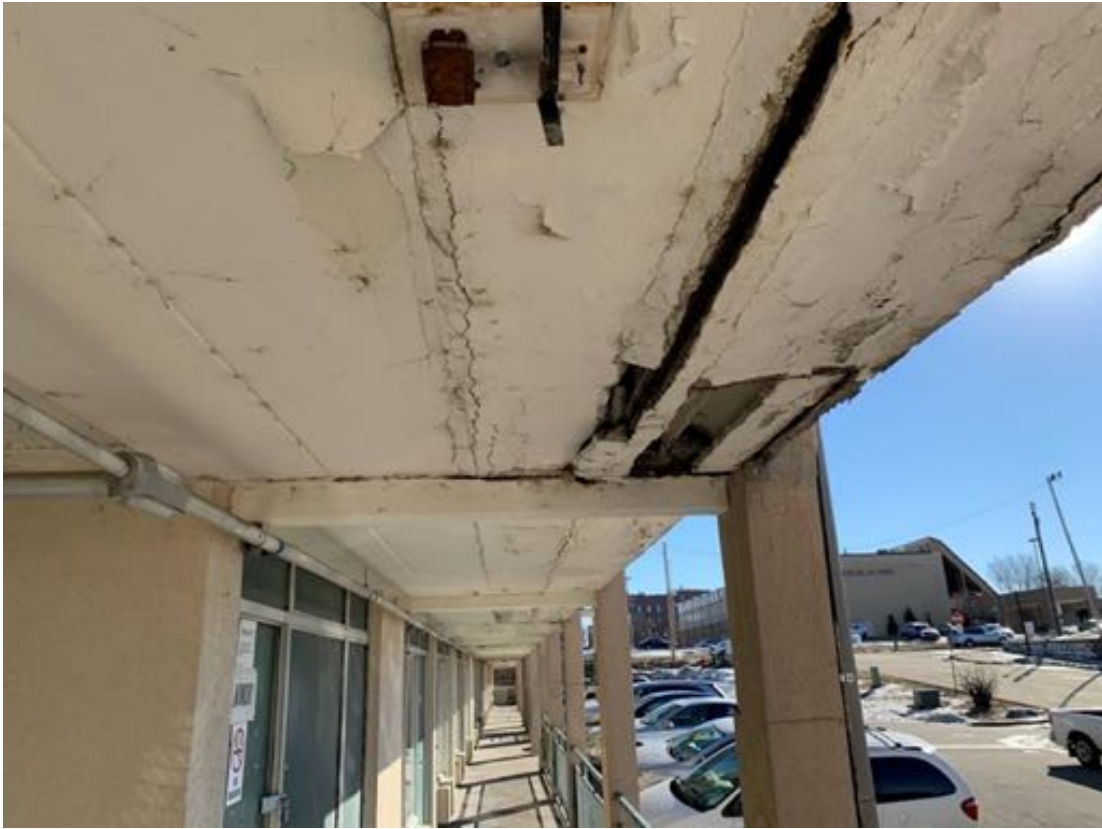
46. Hollow-core slab south of western interior stairwell between 2nd and 3rd level. PHOTO 68
47. Hollow-core slab in front of room 226 between 2nd and 3rd level. PHOTO 69

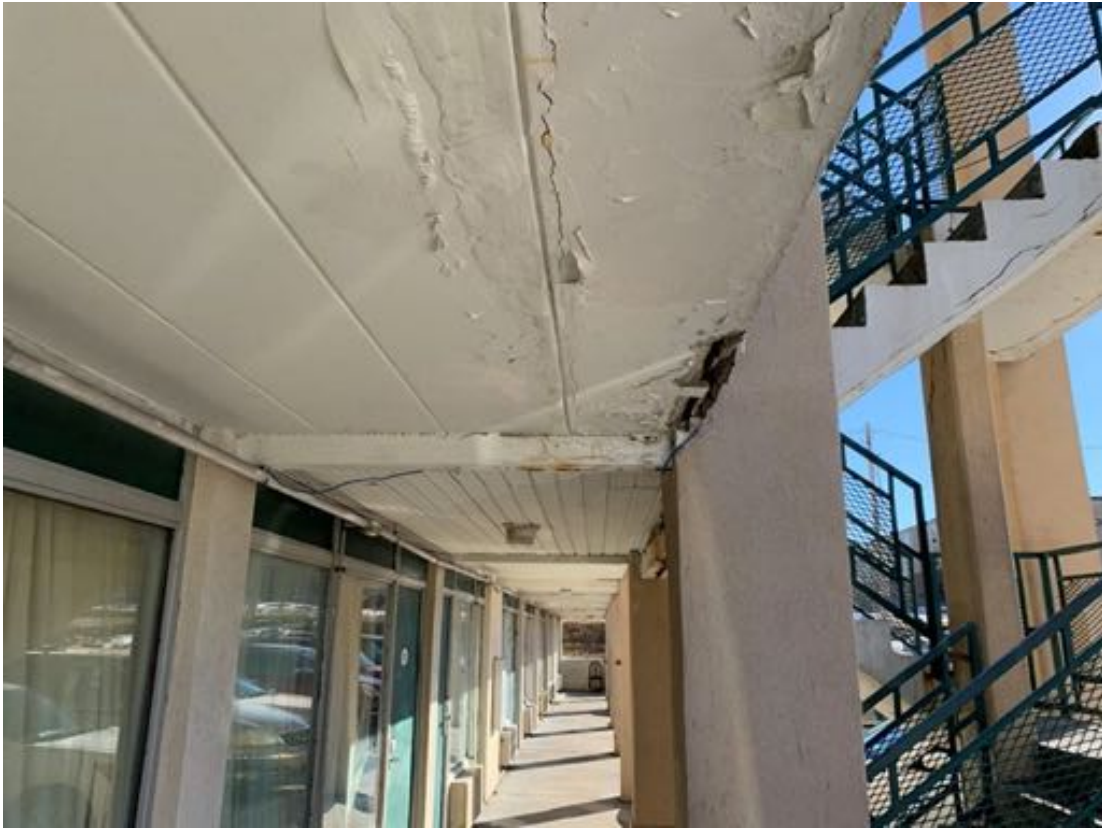
48. Hollow-core slab in front of room 231 between 2nd and 3rd level. PHOTO 70
49. Hollow-core slab in front of room 301 between 3rd and 4th level. PHOTO 71

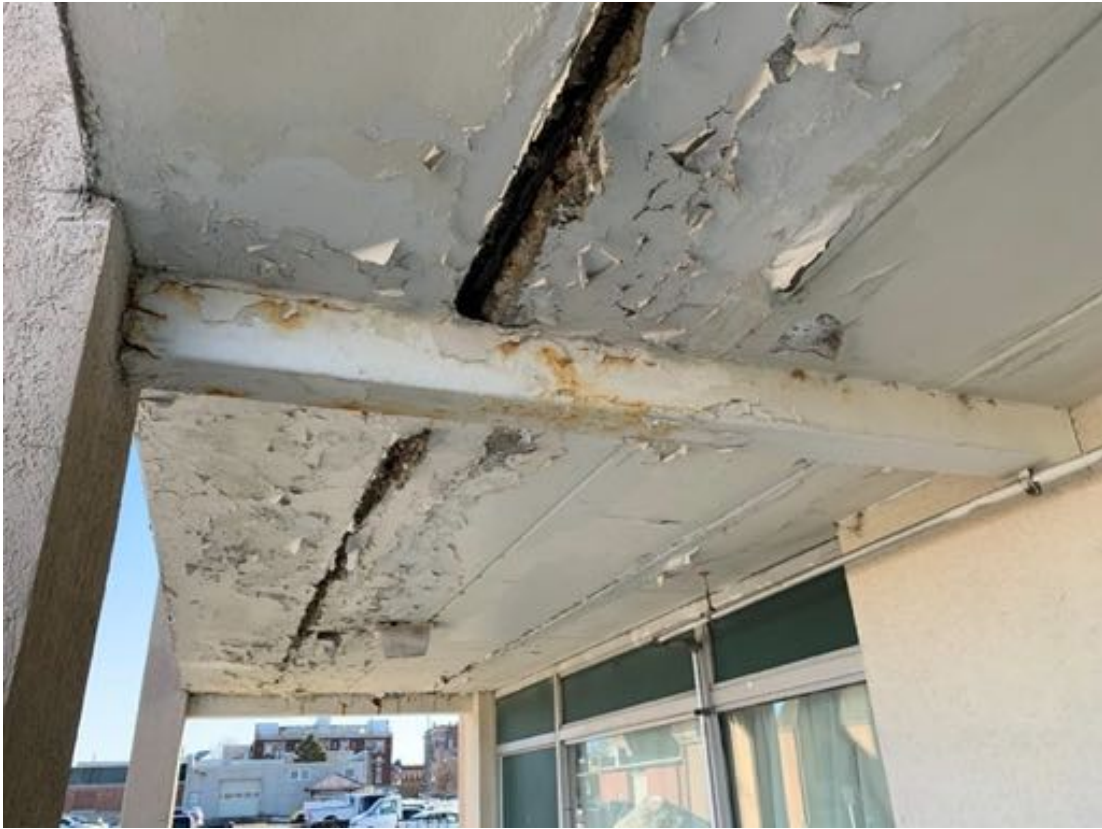
50. Hollow-core slab in front of room 302 between 3rd and 4th level. PHOTO 72
51. Hollow-core slab in front of room 304 between 3rd and 4th level. PHOTO 73

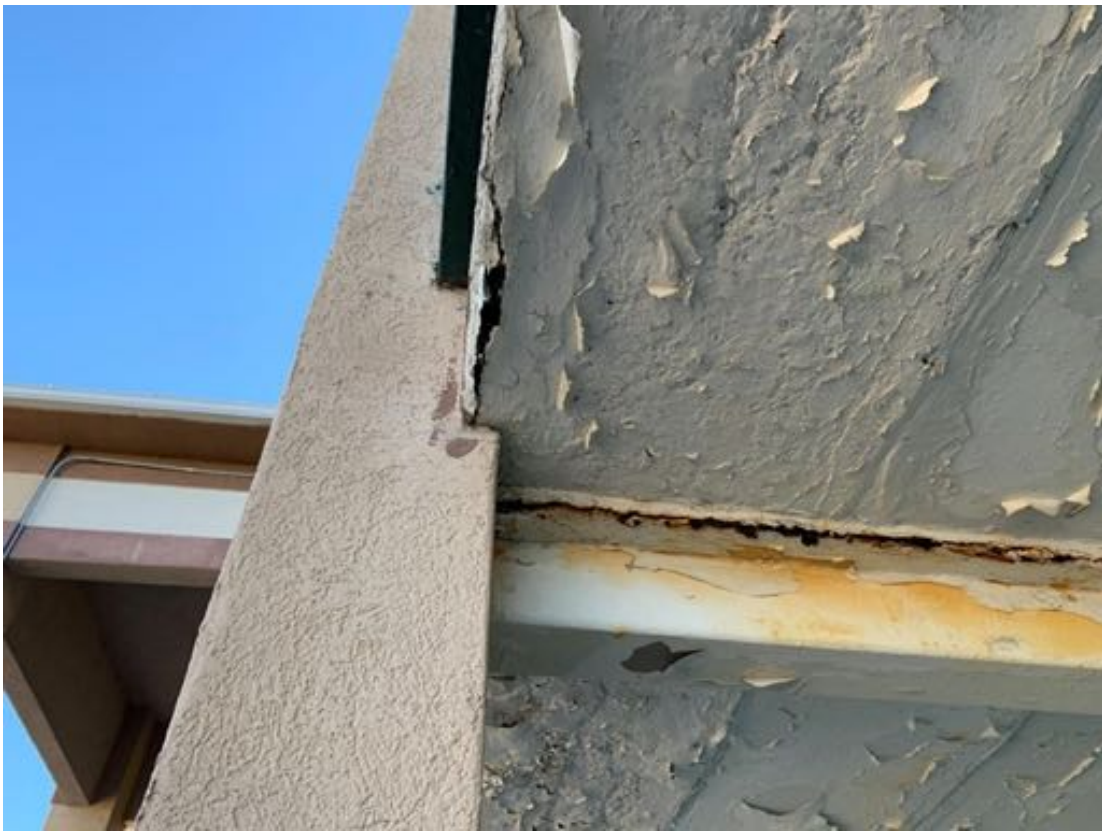
52. Hollow-core slab in front of room 305 between 3rd and 4th level. PHOTO 74
53. Hollow-core slab in front of room 309 between 3rd and 4th level. PHOTO 75

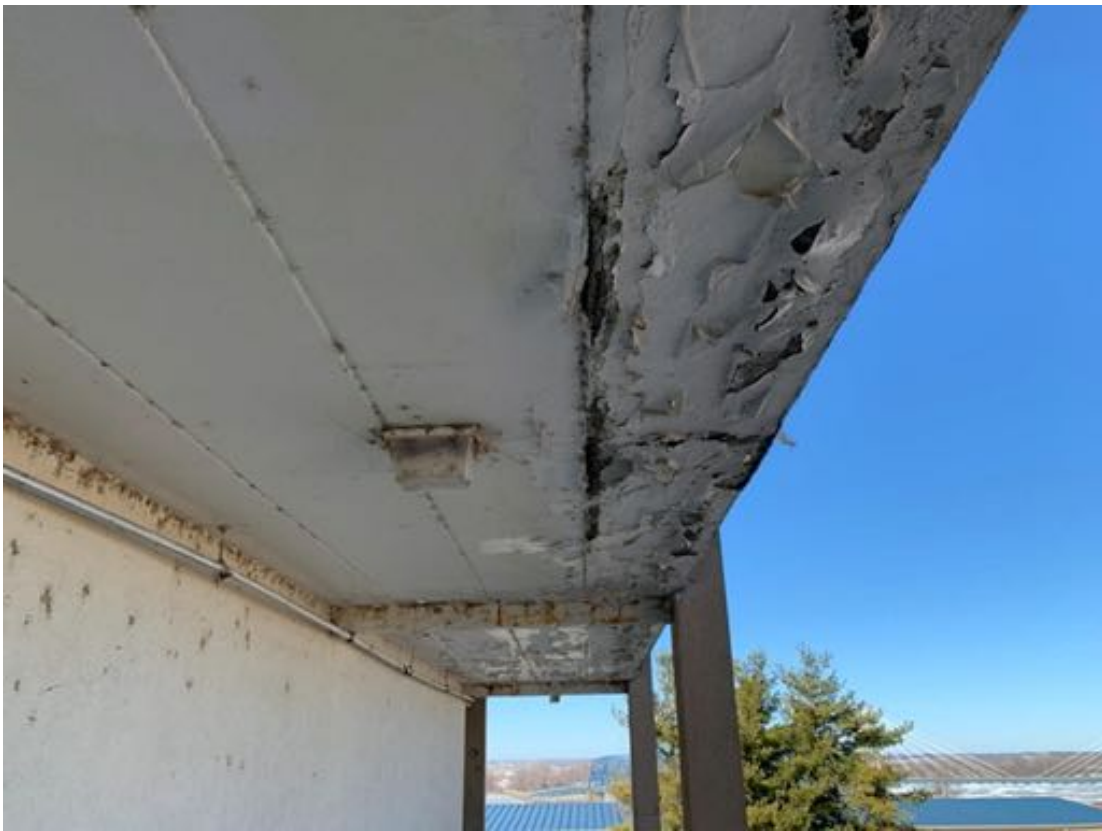
54. Hollow-core slab in front of room 314 between 3rd and 4th level. PHOTO 76
55. Hollow-core slab to the west of room 317 (second full length slab from west end of building) between 3rd and 4th level. PHOTO 77

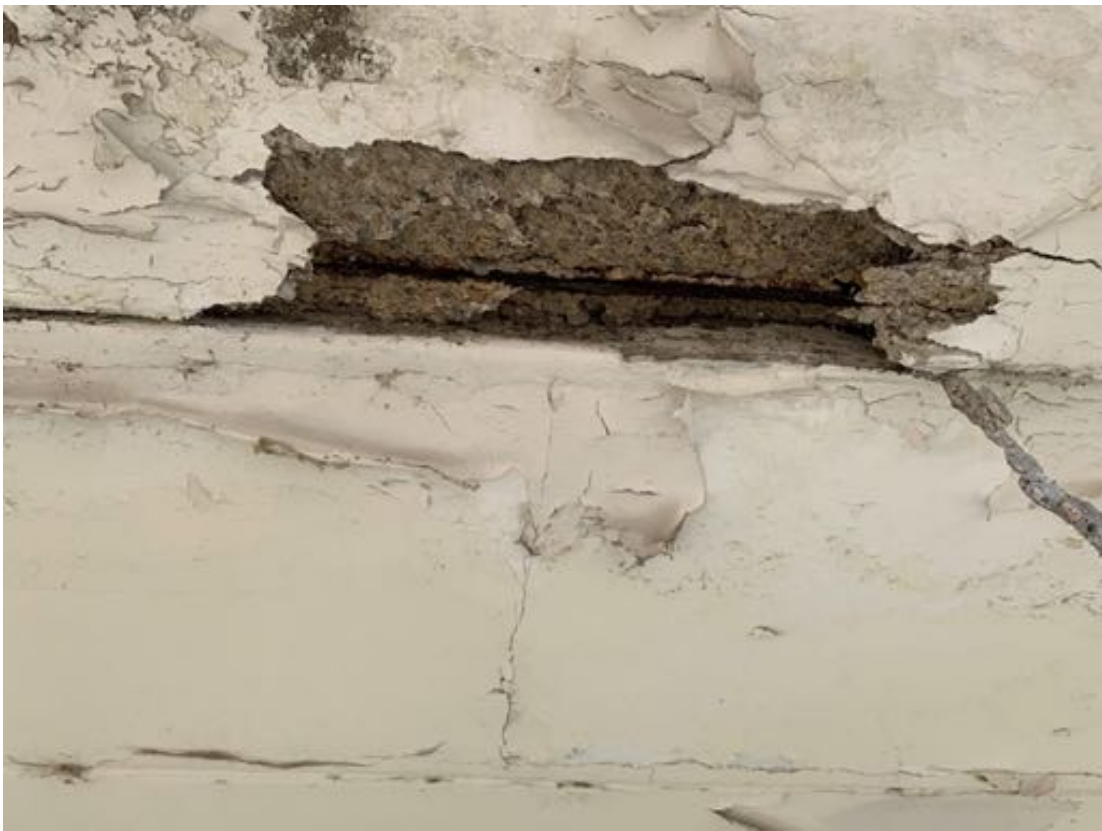
56. Hollow-core slab in front of room 324 between 3rd and 4th level. PHOTO 78
57. Hollow-core slab on south side of western interior stairwell between 3rd and 4th level. PHOTO 79

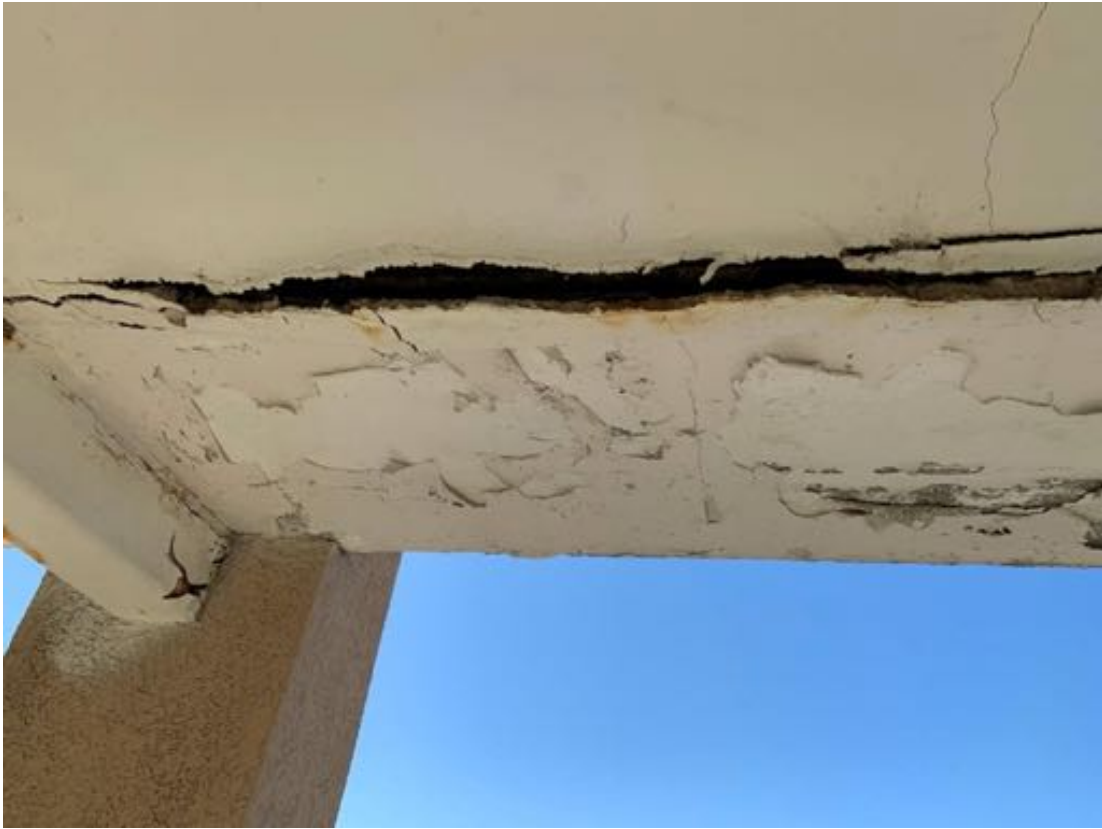
58. Hollow-core slab in front of room 325 (unmarked room) between 3rd and 4th level. PHOTO 80
59. Hollow-core slab in front of room 326 between 3rd and 4th level. PHOTO 81

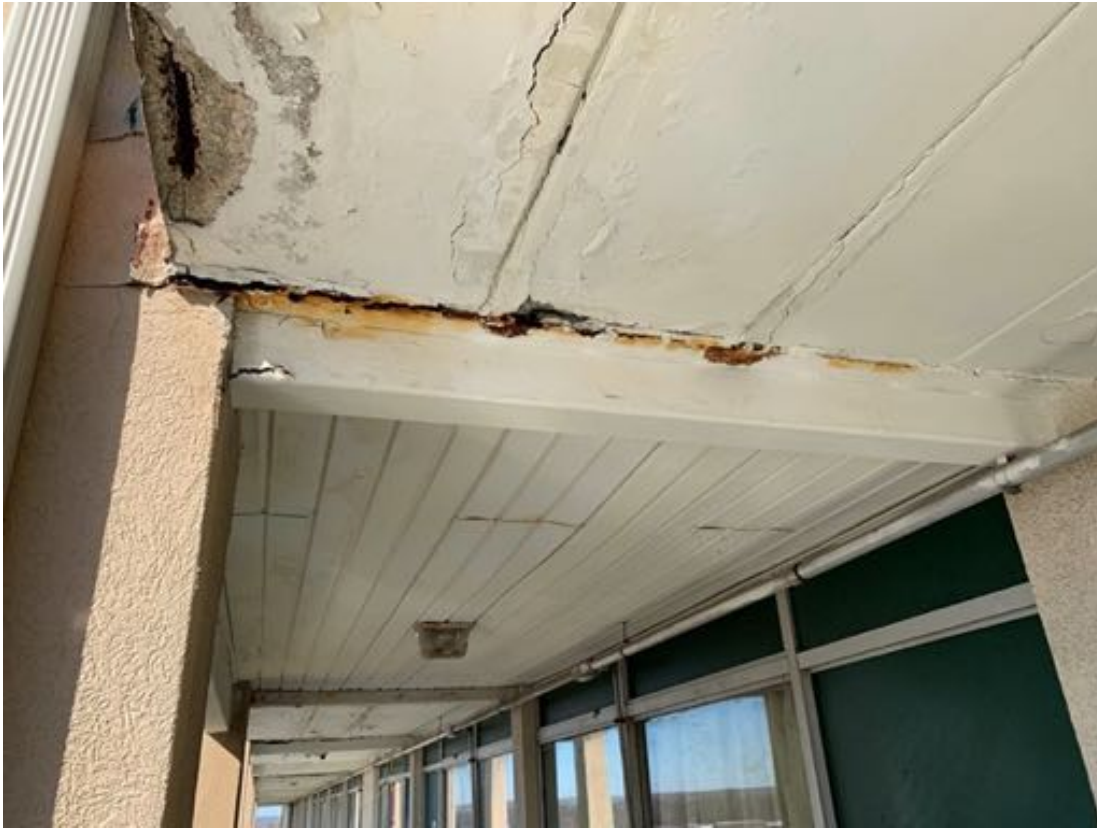
60. Hollow-core slab in front of room 333 between 3rd and 4th level. PHOTO 82
