March 4, 2021

Quincy Property, L.L.C.
900 NW Vesper Road
Blue Springs, MO 64015

RE: Structural Assessment of Building at 200 Maine Street, Quincy, IL

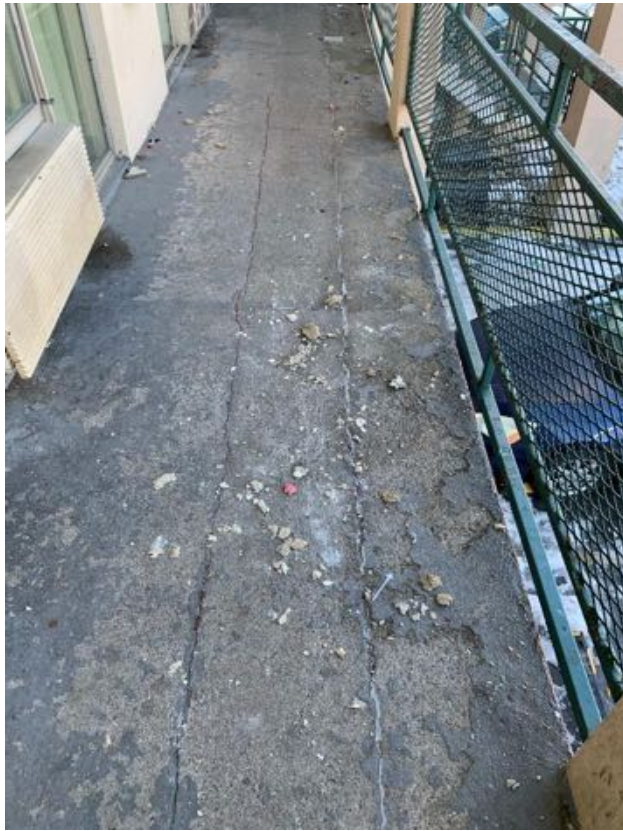
PHOTO 5

3. Corrosion of railings at support points shown in PHOTO 4.
4. Longitudinal cracking of exterior walkway hollow-core precast panels at construction joints (PHOTO 5) and adjacent to construction joints (PHOTO 6).

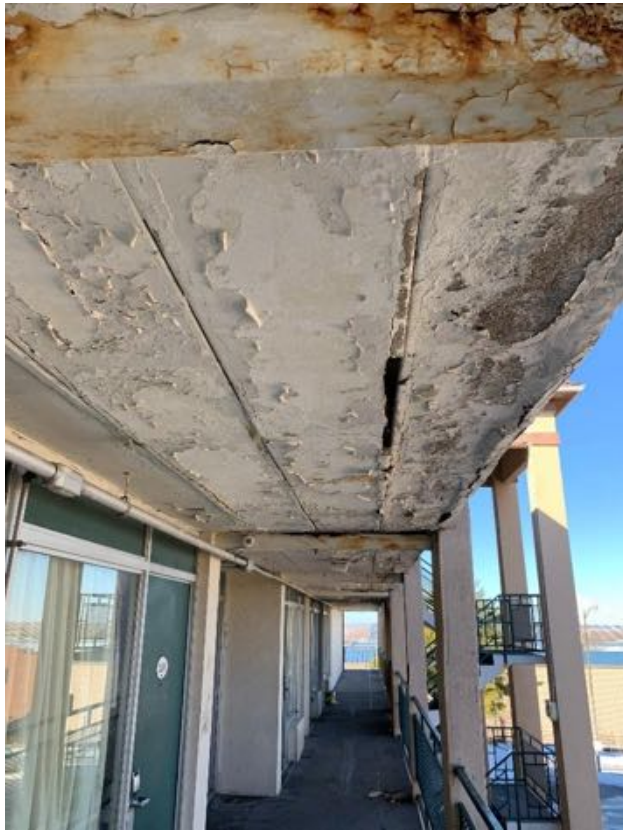
PHOTO 17

13. Longitudinal cracking parallel to panel joints on the underside of the exterior walkway exposing reinforcing strands shown in PHOTO 17.
14. Spalling of steps in exterior stairwells shown in PHOTO 18.
15. Longitudinal cracking on the underside of stairway flights in exterior walkways shown in PHOTO 19.

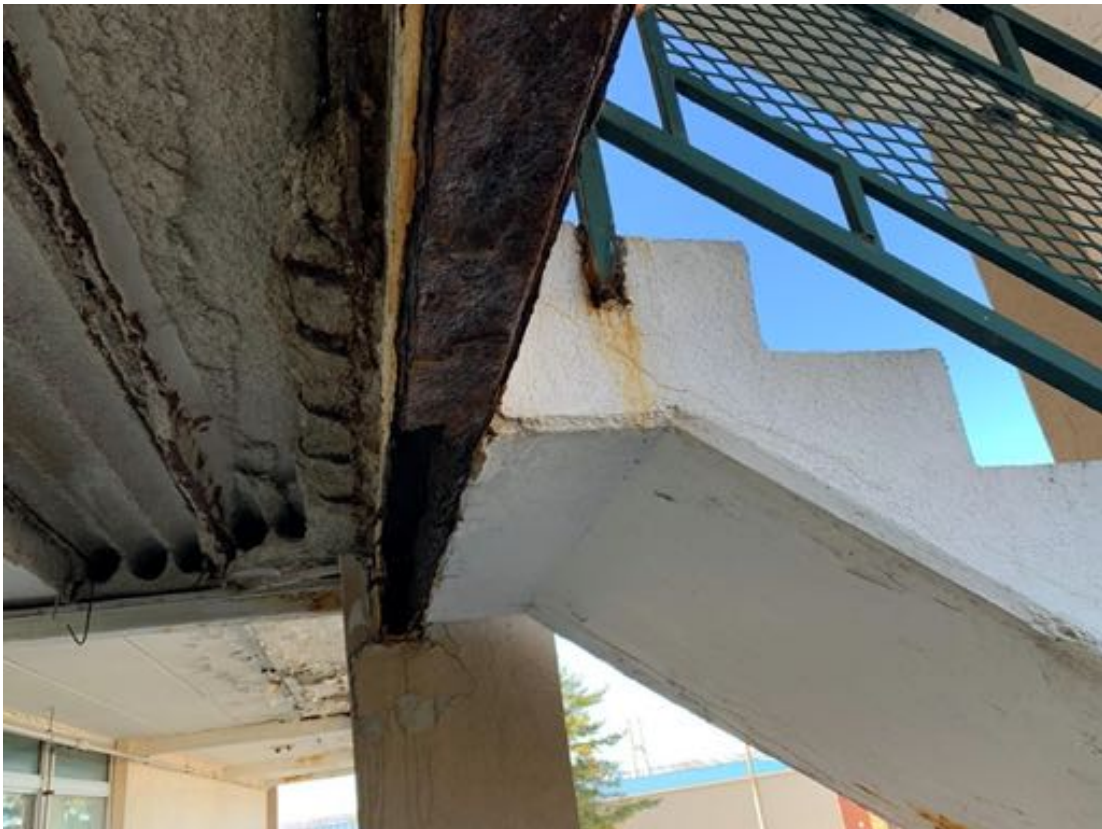
1. Stairway flight from 2nd level landing to intermediate landing between levels 2 and 3 in the northwest stairwell. PHOTO 23
2. Steel HSS beam supporting 3rd level landing in northwest stairwell. PHOTO 24
3. Intermediate landing between 2nd and 3rd level in the northwest stairwell. PHOTO 25
4. Hand railing in the northwest stairwell. PHOTO 26
5. Intermediate landing between ground level and 2nd floor in the northwest stairwell. PHOTO 27

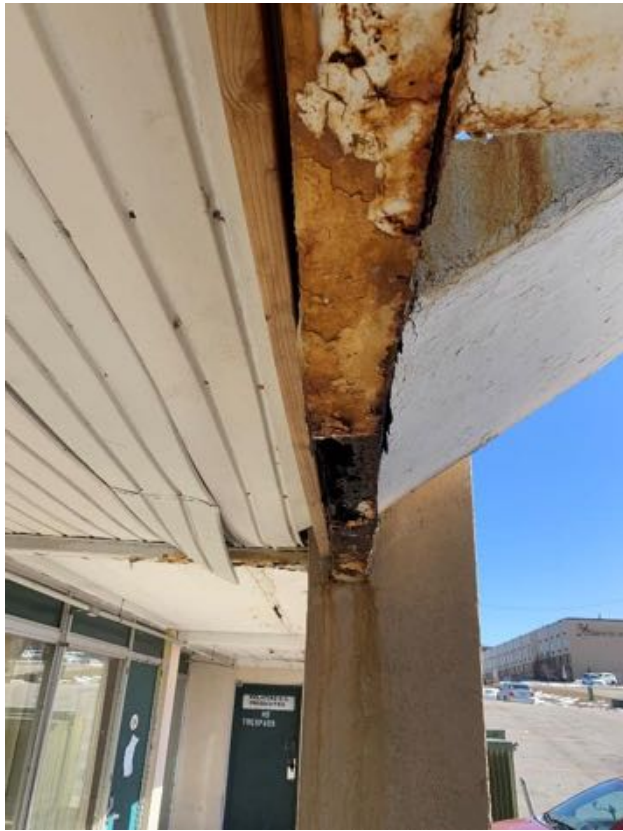
PHOTO 38

16. Steel HSS beam supporting the 2nd floor landing in the southwest stairwell. PHOTO38
17. Hand railing between the 1st level and the 2nd level in the southwest stairwell. PHOTO 39

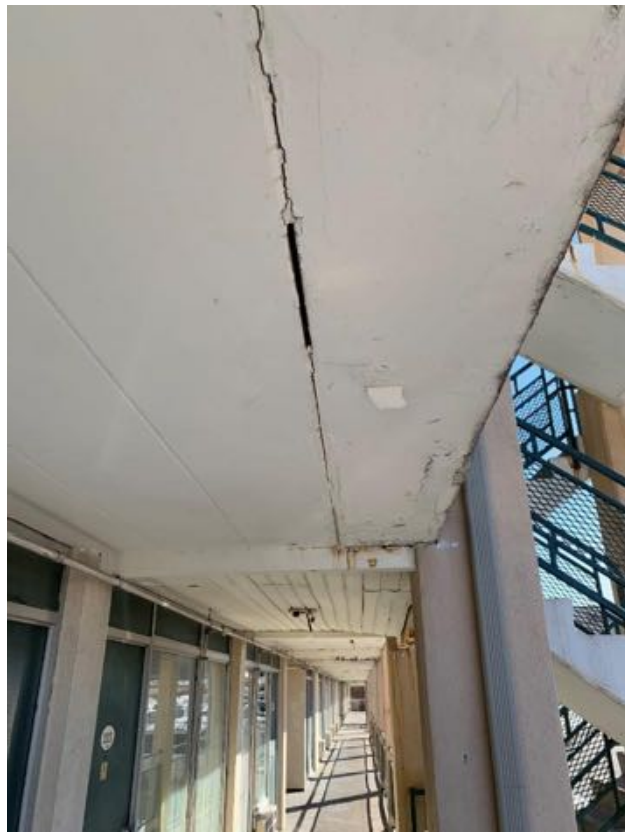
42. Hollow-core slab west of room 222 (second to last full-length slab from west end of building) between 2nd and 3rd level. PHOTO 64
43. Hollow-core slab in front of room 222 between 2nd and 3rd level. PHOTO 65

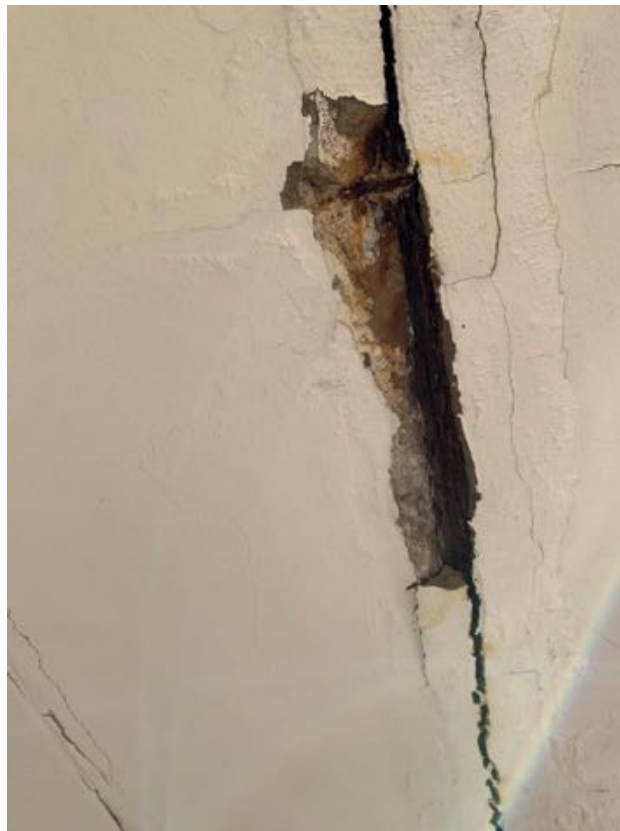
44. Hollow-core slab in front of room 223 between 2nd and 3rd level. PHOTO 66
45. Hollow-core slab in front of room 224 between 2nd and 3rd level. PHOTO 67

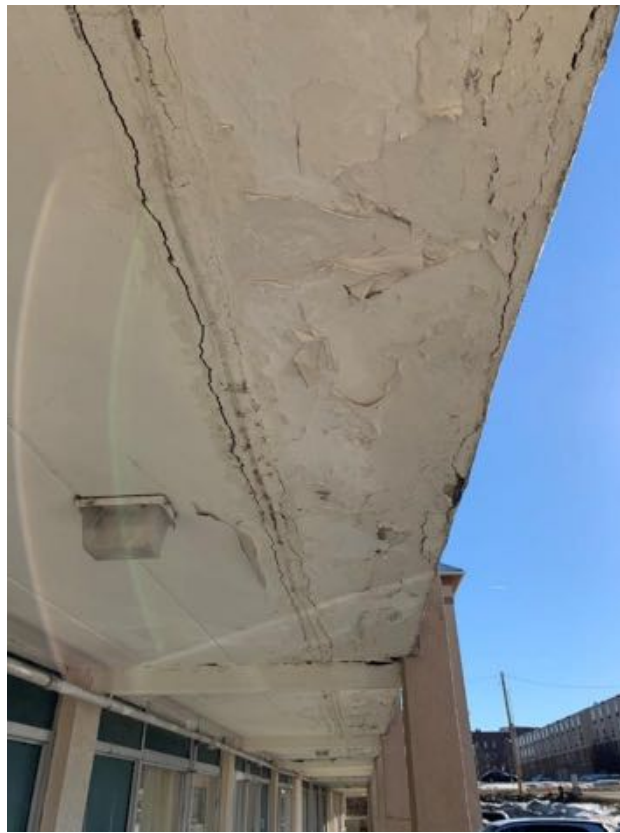
46. Hollow-core slab south of western interior stairwell between 2nd and 3rd level. PHOTO 68
47. Hollow-core slab in front of room 226 between 2nd and 3rd level. PHOTO 69

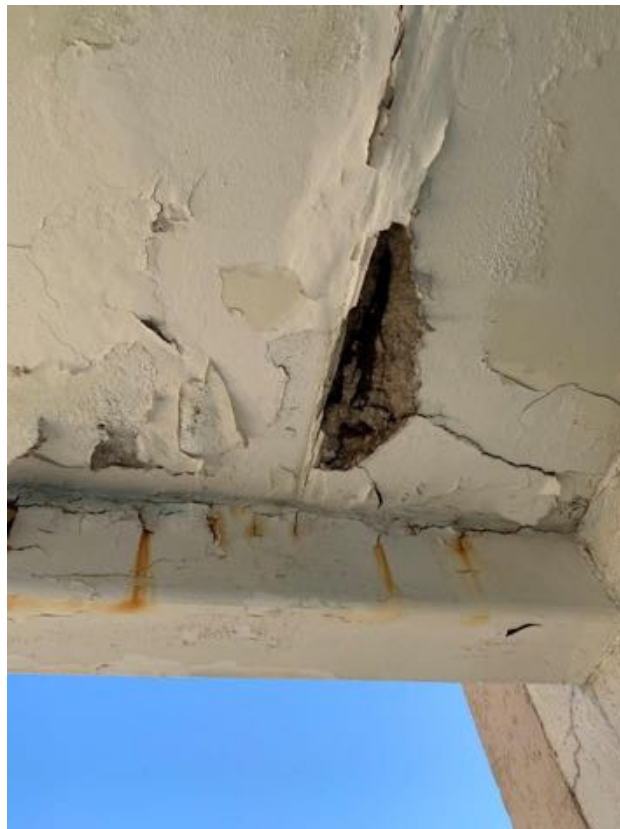
48. Hollow-core slab in front of room 231 between 2nd and 3rd level. PHOTO 70
49. Hollow-core slab in front of room 301 between 3rd and 4th level. PHOTO 71

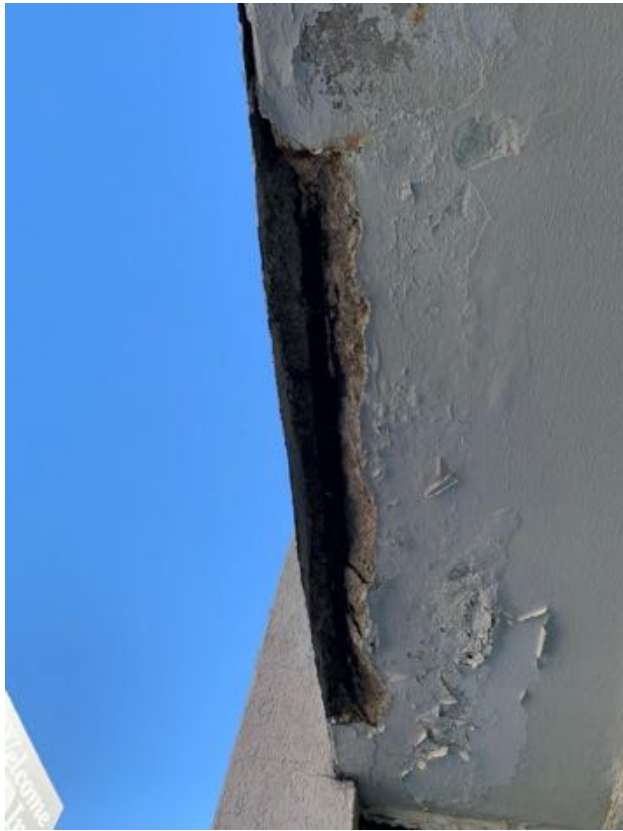
52. Hollow-core slab in front of room 305 between 3rd and 4th level. PHOTO 74
53. Hollow-core slab in front of room 309 between 3rd and 4th level. PHOTO 75

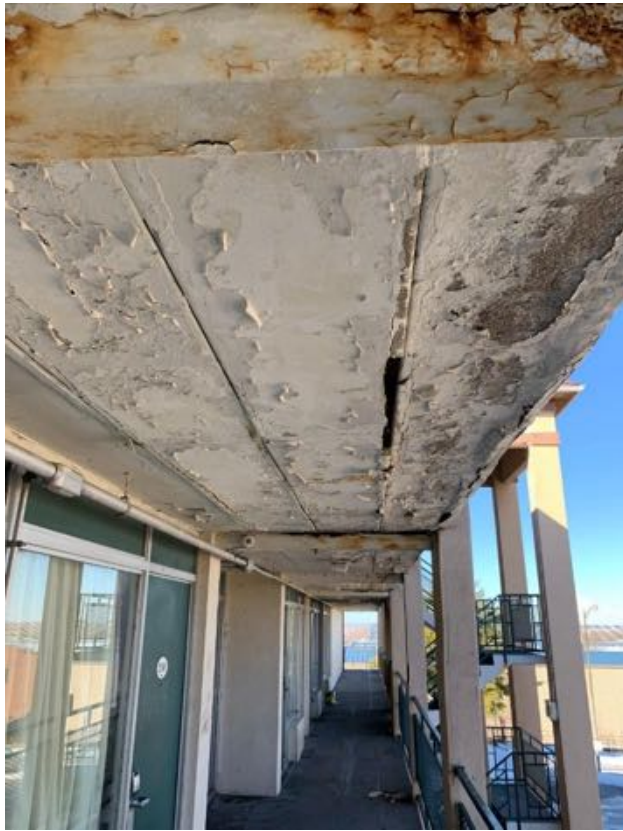
54. Hollow-core slab in front of room 314 between 3rd and 4th level. PHOTO 76
55. Hollow-core slab to the west of room 317 (second full length slab from west end of building) between 3rd and 4th level. PHOTO 77

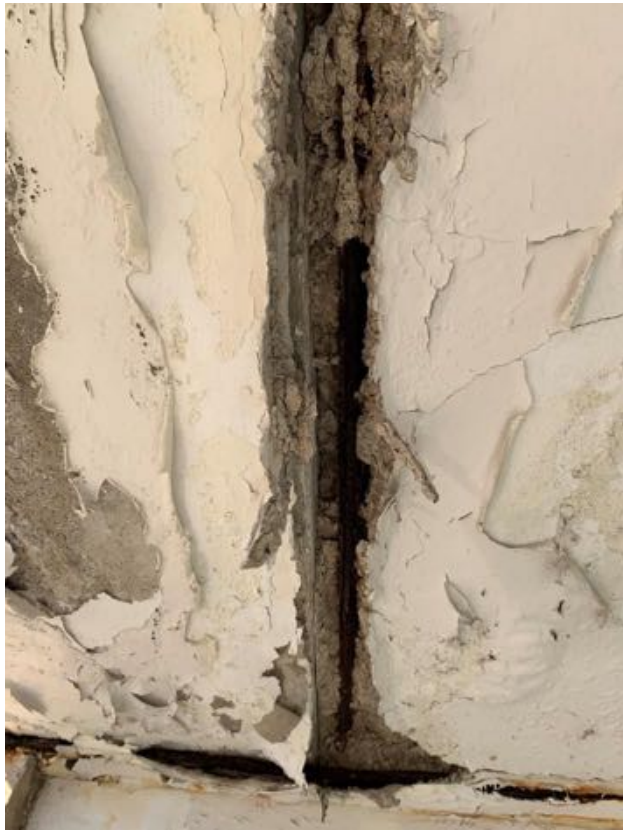
56. Hollow-core slab in front of room 324 between 3rd and 4th level. PHOTO 78
57. Hollow-core slab on south side of western interior stairwell between 3rd and 4th level. PHOTO 79
